SITULA EMT09-554.665 - TIN BRONZE - IRON AGE - SWITZERLAND

Artefact name	Situla EMT09-554.665
Authors	Christian. Degriigny (HE-Arc CR, Neuchâtel, Neuchâtel, Switzerland) & Marie-Jeanne. Scholl (HE-Arc CR, Neuchâtel, Neuchâtel, Switzerland) & Valentin. Boissonnas (HE-Arc CR, Neuchâtel, Neuchâtel, Switzerland)
Url	/artefacts/692/

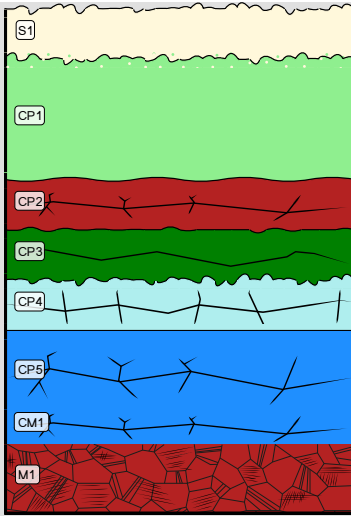
There are 2 stratigraphies (Fig. 5 corresponding to the interior face of the situla and Fig. 6 to its exterior face). The strata are similar in composition but their coding is different: CP1 to CP3 in Fig. 5 correspond to CP3 to CP5 in Fig. 6. Since the stratigraphy of Fig. 6 is more complete, the composition of each of its strata is given below.

Fig. 6: Stratigraphic representation of the sample taken from the detached fragment of the situla in cross-section (dark field) using the MiCorr application. The characteristics of the strata are only accessible by clicking on the drawing that redirects you to the search tool by stratigraphy representation. This representation shows the interior face and can be compared to Fig. 10 (top red rectangle), Credit HE-Arc CR, M-J.Scholl.
