# CHISEL POINT DEV 995/1069 PR – EUTECTOID TO HYPEREUTECTOID STEEL – EARLY MEDIEVAL TIMES – SWITZERLAND

| Artefact name | Chisel point DEV 995/1069 PR |
| Authors | Marianne. Senn (EMPA, Dübendorf, Zurich, Switzerland) & Christian. Degrieny (HE-Arc CR, Neuchâtel, Neuchâtel, Switzerland) |

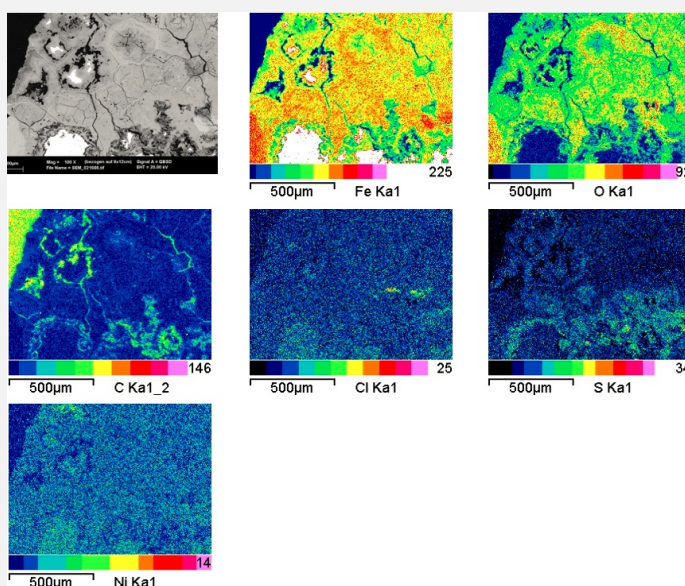
The metal is heavily corroded and the thickness of the corrosion crust is irregular, but averages about 0.5mm. The corrosion products enclose different ghost structures: the corrosion crust has preserved the shape of polygonal grains (Figs. 11 and 13) and cementite needles (Fig. 12). Under polarised light, the corrosion products at the metal - corrosion crust interface are dark-red and form an inner S-rich layer (CP3, Figs. 11 and 13). Cl occurs locally (CP3) and C is present in layers CP2 and CP3 (Fig. 13). The outer layer of the corrosion products (CP1) is orange and contains more O than the inner layer CP3 (Figs. 11 and 14).

Fig. 12: Micrograph showing the metal - corrosion crust interface from Fig. 3 (detail), unetched, bright field. The cementite is visible as white needles in the metal and its ghost structure as black needles in the corrosion crust,
