# MILITARY ID TAG 5668-MXX-1008-1 - ZN PB ALLOY - MODERN TIMES - FRANCE

<b>Artefact name</b>	Military ID tag 5668-MXX-1008-1
<b>Authors</b>	Christian. Degryny (HE-Arc CR, Neuchâtel, Neuchâtel, Switzerland) & Marie-Jeanne. Scholl (HE-Arc CR, Neuchâtel, Neuchâtel, Switzerland) & Valentin. Boissonnas (HE-Arc CR, Neuchâtel, Neuchâtel, Switzerland)
<b>Url</b>	/artefacts/706/

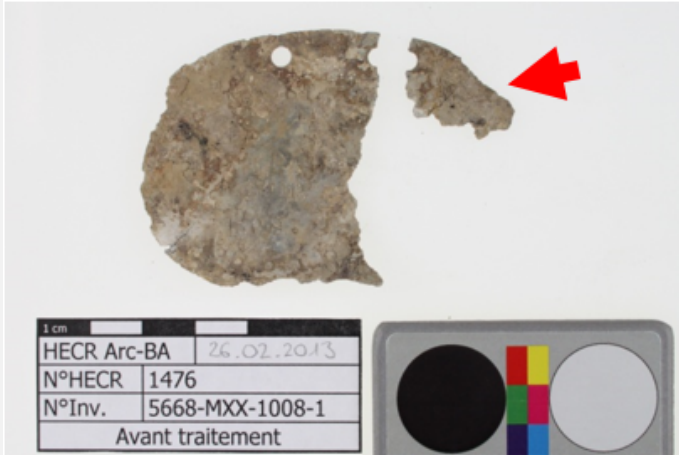
Fig. 2: Location of sample,

<b>Description of sample</b>	This sample was cut out of fragment b in Fig. 1. The cross-section shows the entire thickness of the plate (L = 8 mm, W= 1 mm). The corrosion goes through the whole metal thickness but a metallic core remains (Figs. 4 and 7).
<b>Alloy</b>	Zn Pb Alloy
<b>Technology</b>	Cold worked (laminated)
<b>Lab number of sample</b>	None
<b>Sample location</b>	HE-Arc CR, Neuchâtel, Neuchâtel
<b>Responsible institution</b>	Pôle d'Archéologie Interdépartemental Rhénan, Sélestat, Alsace
<b>Date and aim of sampling</b>	2013, metallography and chemical analyses
