# SHOE NAIL 2637 1370.B. – HYPOEUTECTOID STEEL – ROMAN TIMES – SWITZERLAND

**Artefact name** Shoe nail 2637 1370.B.

**Authors** Christian. Degriigny (HE-Arc CR, Neuchâtel, Neuchâtel, Switzerland) & Valentin. Boissonnas (HE-Arc CR, Neuchâtel, Neuchâtel, Switzerland) & Vincent Chappuis. (HE-Arc CR, Neuchâtel, Neuchâtel, Switzerland)

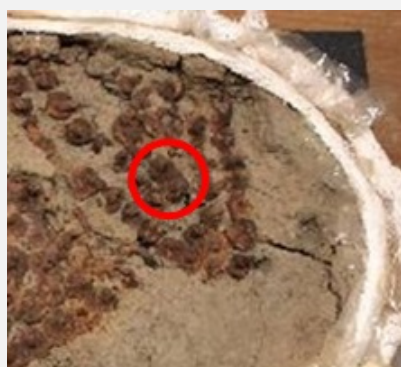
Fig. 2: Incomplete shoe from which the nail was sampled (in red circle),

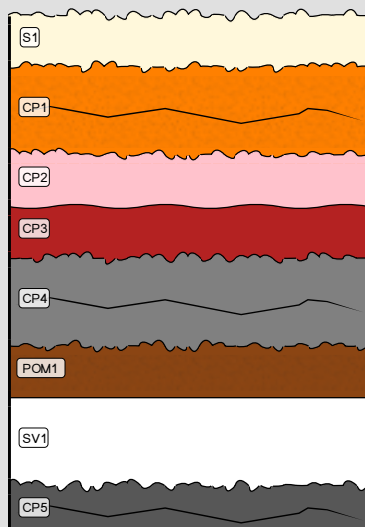
Fig. 5: Stratigraphic representation of the nail in cross-section (dark field) using the MiCorr application. The characteristics of the strata are only accessible by clicking on the drawing that redirects you to the search tool by stratigraphy representation. This representation can be compared to Fig. 14, Credit HE-Arc CR, V.Chappuis.

Fig. 6: Stratigraphic representation of the nail in cross-section (dark field) using the MiCorr application. The characteristics of the strata are only accessible by clicking on the drawing that redirects you to the search tool by stratigraphy representation. This representation can be compared to Fig. 14, Credit HE-Arc CR, V.Chappuis.
