# COFFEE FILTER – AL ALLOY – MODERN TIMES – FRANCE

**Artefact name** Coffee filter

**Authors** Christian. Degriigny (HE-Arc CR, Neuchâtel, Neuchâtel, Switzerland)

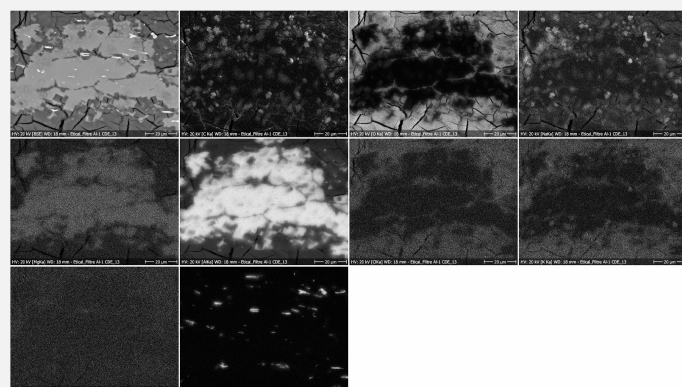
The average thickness of the corrosion layer (CP1) is about 50 micrometers, but may be thinner or thicker depending on the area. Intergranular corrosion developed locally to extend through the entire thickness of the metal. EDS-SEM

analysis indicates that the metal is, as expected, covered by a layer rich in Al and O containing chlorides (red spots on Fig. 9) and surprisingly Na (Figs. 10 and 11). Chlorides do not seem to form active corrosion. A new examination carried out after 4 months (Fig. 12) shows new forms of alteration with a local enrichment of Na, C and O (Na<sub>2</sub>CO<sub>3</sub>?).

Fig. 9: SEM picture (detail of Fig. 4 with location (red spots) of EDS analyses of Fig. 10), BSE-mode. From bottom to top left: the metal (M1) in light grey, the corroded metal (CM1) and CP1. The area selected for elemental chemical distributions (Figs. 11 and 12) is marked by a rectangle,
