RAIN GUTTER FRAGMENT – GREY CAST IRON – MODERN TIMES – FRANCE

Rain gutter fragment

Christian. Degrigny (HE-Arc CR, Neuchâtel, Neuchâtel, Switzerland) & Mathea. Hovind (University of Oslo, Department of archaeology, conservation and history (IAKH-UiO), Oslo, Oslo, Norway)

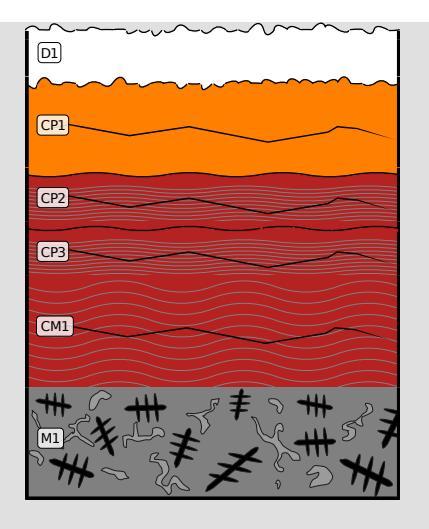
The interior face (Figs. 2 and 4) shows similar characteristics but does not include a white layer similar to NMM1. The fracture edge however (Figs. 2, 4 and 10), shows a more complex stratigraphy consisting of a dense product layer which can be further divided into two individual strata (CP3 and CP2), superimposed by a porous corrosion crust appearing orange under polarized light (CP1) (Fig. 11). The corroded metal (CM1) is located just beneath CP3 and contains remnants of the P-rich eutectic phase (Figs. 10-12). The M/CP ratio (metal to corrosion products) is rather high, implying extensive internal corrosion. Furthermore, a simple crack is traversing the corrosion layers – indicating a fragilization of the structure. As for the composition of the corrosion products CP1, CP2 and CP3, they all contain Fe and O (Fig. 12). A marbling effect within CP2 and CP3 indicates a variation in the concentration of Fe and O (particularly visible in bright field – Fig. 10). The white deposit (D1 in Fig. 6) might originate from exposure to calcareous water (Table 2). The presence of exogenous elements such as Si, Ca, Al, Na and O (Table 2) was confirmed by elemental mapping (Fig. 12).

Fig. 12: SEM image and elemental chemical distribution of the selected area from Fig. 10. Method of analysis: SEM-EDS. Lab. of Electronic Microscopy and Microanalysis, Néode, HEI Arc,
