VOTIVE FIGURE OF A BAT IVB4168 – GILDED BRASS – MODERN TIMES

Artefact name Votive figure of a bat IVb4168

Authors Christian. Degriigny (HE-Arc CR, Neuchâtel, Neuchâtel, Switzerland) & Naima. Gutknecht (HE-Arc CR, Neuchâtel, Neuchâtel, Switzerland) & Valentin. Boissonnas (HE-Arc CR, Neuchâtel, Neuchâtel, Switzerland)

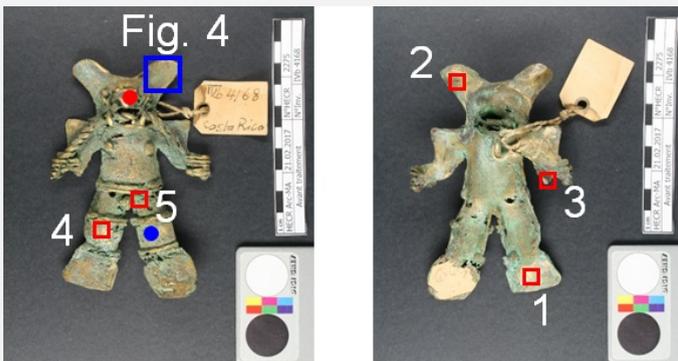
Fig. 2: Bat figure, front (left) and back (right) views with location of Fig. 4 (blue square), XRF analyses (red squares), FTIR analysis with sampling (blue point) and SEM-EDS analysis (red point),

| Description of sample | No sample from the metal was cut. Only a sample of the green corrosion product was taken for FTIR analysis (Fig. 2). |

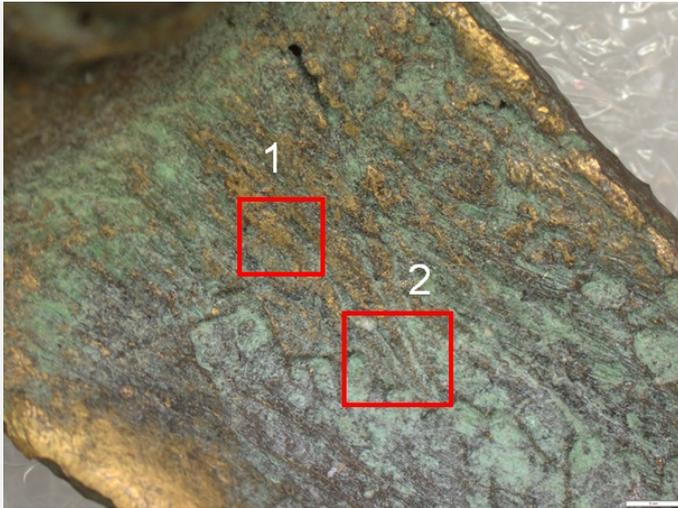
Fig. 4: Location of the areas 1 and 2 used to build the MiCorr stratigraphies of Figs. 5 and 6,

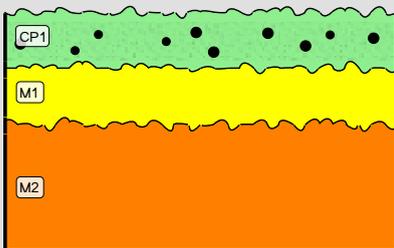
Fig 5: Stratigraphic representation 1 under binocular from Fig. 4 using the MiCorr application. The characteristics of the strata are only accessible by clicking on the drawing that redirects you to the search tool by stratigraphy representation, Credit HE-Arc CR, N.Gutknecht.

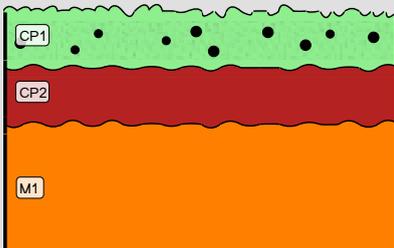
Fig. 6: Stratigraphic representation 2 under binocular from Fig. 4 using the MiCorr application. M1 is M2 in Fig. 5. The characteristics of the strata are only accessible by clicking on the drawing that redirects you to the search tool by stratigraphy representation, Credit HE-Arc CR, N.Gutknecht.
