FUNERAL MASK IVC 11595 - CU/AG, WITH SURFACE ENRICHMENT (AG) - UNKNOWN

Artefact name Funeral mask Ivc 11595

Authors Christian. Degrigny (HE-Arc CR, Neuchâtel, Neuchâtel, Switzerland) & Naima. Gutknecht (HE-Arc CR, Neuchâtel, Neuchâtel, Switzerland) & Valentin. Boissonnas (HE-Arc CR, Neuchâtel, Neuchâtel, Switzerland)

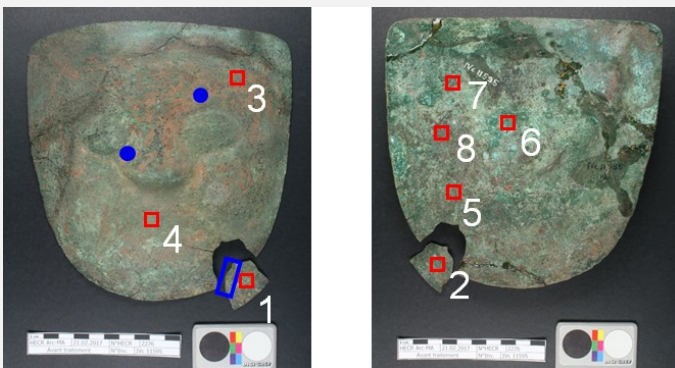
Fig. 2: Front (left) and back (right) faces showing the location of XRF analyses (red squares), sampling areas for SEM-EDS (blue points) and sampling area for examination on cross-section (blue rectangle),

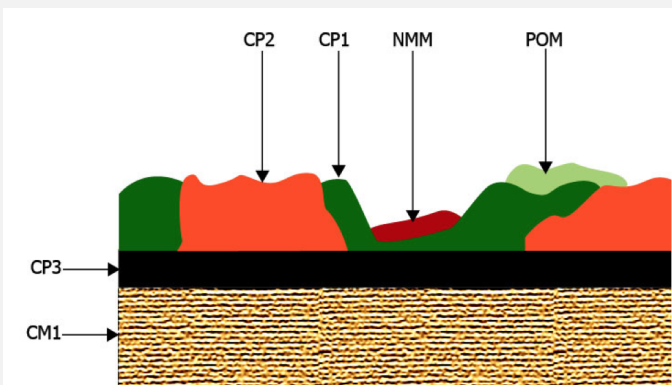
The schematic representation below gives an overview of the corrosion layers encountered on the object from visual macroscopic observation. The first stratigraphy (Fig. 3a) is for the front, while the second (Fig. 3b) represents the back.

Fig. 3a: Stratigraphic representation of the front face of the funeral mask by visual macroscopic observation,

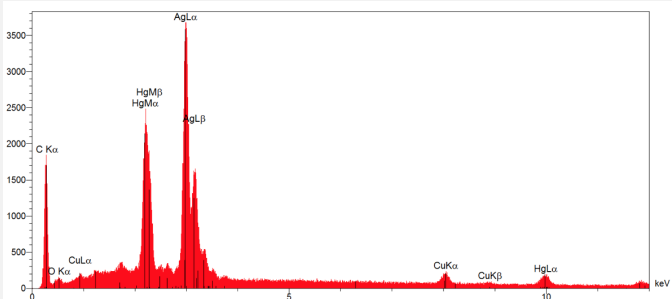
Figs. 10: EDS analysis of the layer that appears light grey under polarized light, situated below the red layer (Fig. 4). Method of analysis: SEM-EDS, Lab of Electronic Microscopy and Microanalysis, IMA (Néode), HEI Arc,

Fig. 11: EDS analysis of the green corrosion layer that has filled the structural void (Fig. 4). Method of analysis: SEM-EDS, Lab of Electronic Microscopy and Microanalysis, IMA (Néode), HEI Arc,

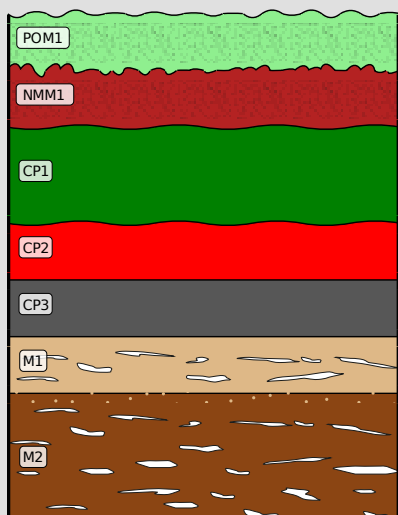
Fig. 15: Stratigraphic representation of the cross-section (dark field) from Figs. 3a or 4 (front of the object) using the MiCorr application. The characteristics of the strata are only accessible by clicking on the drawing that redirects you to the search tool by stratigraphy representation, Credit HE-Arc CR, N. Gutknecht.

Fig. 16: Stratigraphic representation of the cross-section (dark field) from Figs. 3b and 4 (back of the object) using the MiCorr application. CP2 is CP3 while CP3 is CP4 and CP4 is CP2 in Fig. 3b. The characteristics of the strata are only accessible by clicking on the drawing that redirects you to the search tool by stratigraphy representation, Credit HE-Arc CR, N. Gutknecht.

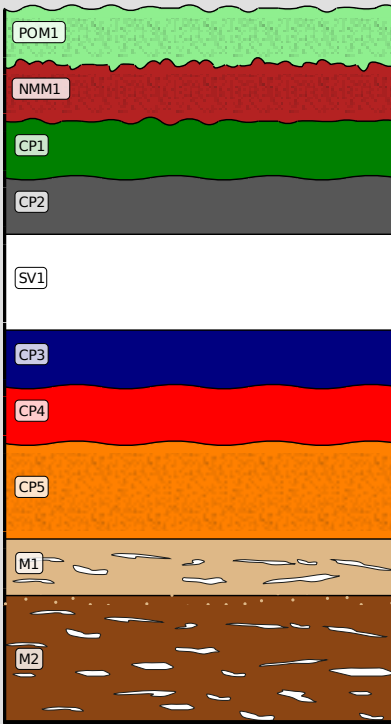
The schematic representation of corrosion layers of Fig. 3 integrating additional information based on the analyses carried out is given in Fig. 17.

Fig. 17: Improved stratigraphic representation of the funeral mask (Fig. 3) based on the results from the SEM-EDS analyses,

The artefact is a repeatedly hammered, annealed and pickled Cu-Ag tumbaga. The cuprite and hydroxycarbonate layers and the presence of chlorides are typical for the corrosion of tumbaga alloys in an archaeological context. Cinnabar has been identified as pigment applied to the surface before burial. Over the centuries, it was partially incorporated into the growing copper corrosion layers. Close to the enriched silver surface and below the cuprite layer a silver- and mercury-rich stratum has formed. Only one publication mentions the reaction of cinnabar with a gold-enriched tumbaga surface but does not go into details about the possible mechanism involved (Masuda 1997).
