FUNERAL MASK IVC 11595 – CU/AG, WITH SURFACE ENRICHMENT (AG) – UNKNOWN

Artefact name Funeral mask IVC 11595

Authors Christian. Degriigny (HE-Arc CR, Neuchâtel, Neuchâtel, Switzerland) & Naima. Gutknecht (HE-Arc CR, Neuchâtel, Neuchâtel, Switzerland) & Valentin. Boissonnas (HE-Arc CR, Neuchâtel, Neuchâtel, Switzerland)

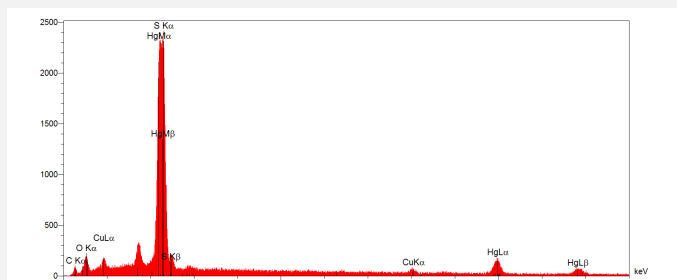
The silver sulphide (HgS, cinnabar, Fig. 13), present as a red pigment on the silver surface, could have been reduced through an electrochemical process in the presence of chlorides (Keune 2005). The released sulfur recombined with the silver to form black silver sulphide. Above that layer a porous mercury- and silver rich stratum has formed (see Hg & Ag on cartography Fig. 8). It remains unclear if the limitos is located in the silver enriched surface or within this silver-mercury compound (Fig. 7).

Fig. 13: Raman analysis of the red pigment on the surface (red line) and the references for cinnabar (blue line). Method of analysis: Raman spectroscopy, HKB,

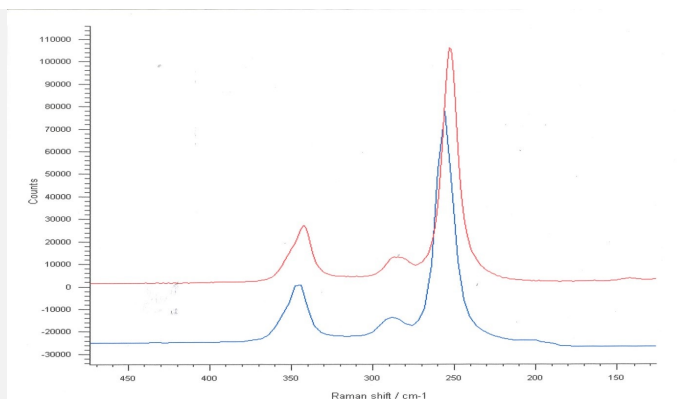
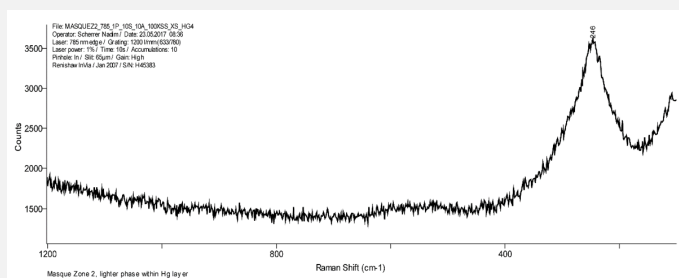
Fig. 14: Raman analysis of the mercury compounds from the cross section. Method of analysis: Raman spectroscopy, HKB,

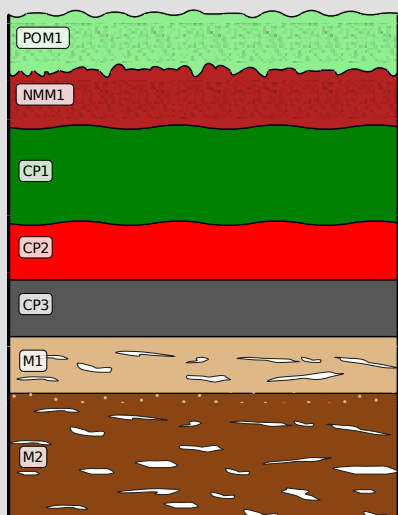
Fig. 15: Stratigraphic representation of the cross-section (dark field) from Figs. 3a or 4 (front of the object) using the MiCorr application. The characteristics of the strata are only accessible by clicking on the drawing that redirects you to the search tool by stratigraphy representation, Credit HE-Arc CR, N. Gutknecht.

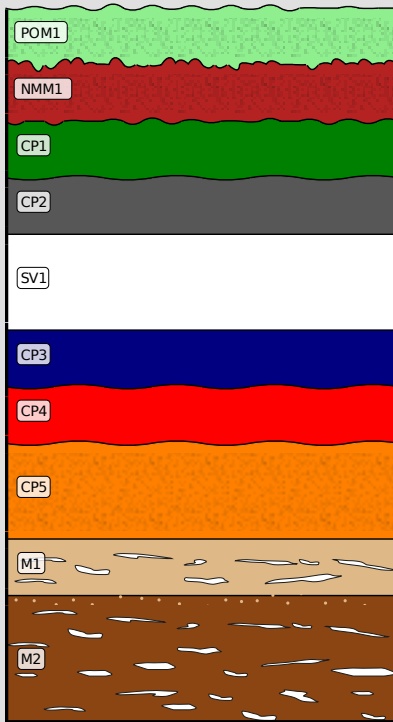
Fig. 16: Stratigraphic representation of the cross-section (dark field) from Figs. 3b and 4 (back of the object) using the MiCorr application. CP2 is CP3 while CP3 is CP4 and CP4 is CP2 in Fig. 3b. The characteristics of the strata are only accessible by clicking on the drawing that redirects you to the search tool by stratigraphy representation, Credit HE-Arc CR, N. Gutknecht.
