FRAGMENT OF AN AEGIS OF NEÏTH 1886.305.0096 – LEADED BRONZE

Artefact name Fragment of an Aegis of Neïth 1886.305.0096

Authors Line. Pedersen (HE-Arc, Neuchâtel, Neuchâtel, Switzerland) & Christian. Degrigny (HE-Arc CR, Neuchâtel, Neuchâtel, Switzerland) & Valentin. Boissonnas (HE-Arc CR, Neuchâtel, Neuchâtel, Switzerland)

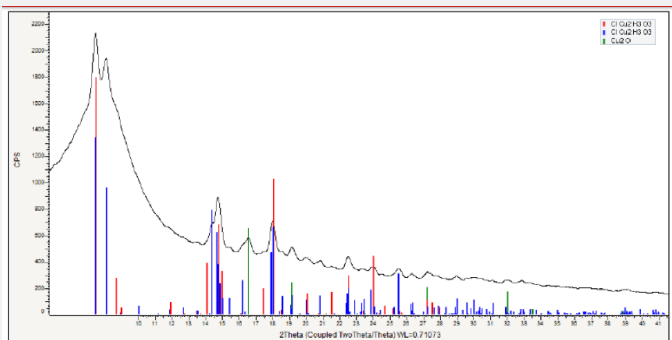
The corrosion crust covers the whole object and is heterogenous. It is formed by multiple layers which are particularly hard and can hardly be removed with the scalpel. The corrosion can be divided into three main layers: an outer green layer followed by a dense and hard red layer, followed by a black layer that contains corresponding markers and the limit of the original surface. In some areas this sequence is regular and clear. In other areas the limit has been replaced by more porous green-red corrosion products which do not contain any corresponding markers. In certain areas the limit and internal corrosion layers have been replaced by structural voids. XRD analysis (Table 2) of these different layers indicates that the upper hard and thick, green corrosion product (Figs. 13-14, CP1.1 and 1.2 in Figs. 6-7) is composed of copper oxychlorides: atacamite and paratacamite ($\text{Cu}_2\text{Cl}(\text{OH})_3$) (Fig. 21).

Fig. 21: XRD spectrum of the sample of the dark green corrosion product showing the presence of atacamite and paratacamite ($\text{Cu}_2\text{Cl}(\text{OH})_3$) as major compound and cuprite (Cu_2O) as minor compound,
