ROOF GUTTER ELEMENT – ZN ALLOY – MODERN TIMES – FRANCE

Artefact name	Roof gutter element
Authors	Christian. Degriigny (HE-Arc CR, Neuchâtel, Neuchâtel, Switzerland) & Mathea. Hovind (University of Oslo, Department of archaeology, conservation and history (IAKH-UiO), Oslo, Oslo, Norway)
Url	/artefacts/880/

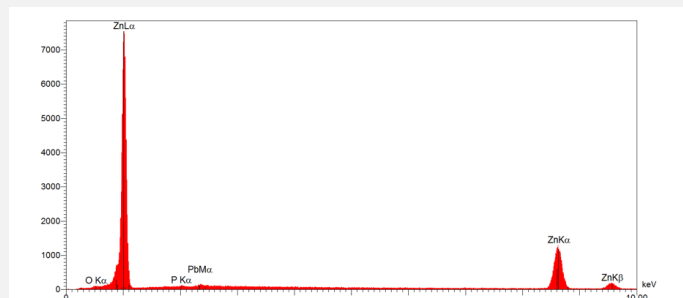
The roof gutter element is composed of Zn with P and Pb at lower concentrations (Fig. 5). The latter is probably originating from the solder that was applied to adjoin several metal sheets for the roof gutter.

Fig. 5: Chemical composition of the metal. Method of analysis: SEM-EDS. Lab. of Electronic Microscopy and Microanalysis, Néode, HEI Arc,
