LEAD CAMES OF A STAINED GLASS WINDOW 52583 – UNKNOWN – SWITZERLAND

Artefact name	Lead comes of a stained glass window 52583
Authors	Alice Gerber. (Haute École Arc Neuchâtel, Neuchâtel, Neuchâtel, Switzerland)
Url	/artefacts/884/

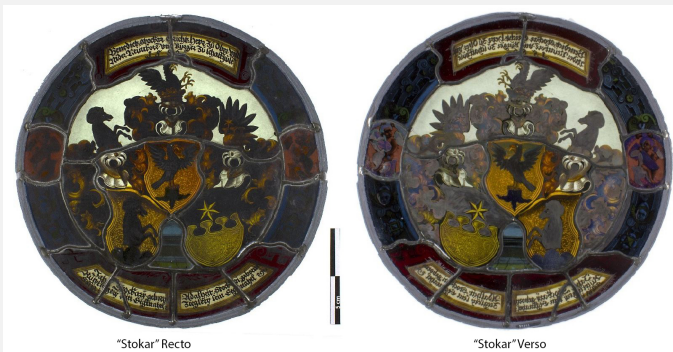
Fig. 1: Stained glass panel "Stokar" both sides,

In 2009 two stained glass panels were placed in a showcase for a permanent exhibition, the lead came were then in a good conservation condition. In 2018, the lead showed voluminous efflorescence of white, powdery corrosion products.

The environment of this showcase contained a high level of acetic acid. Lead being sensitive to organic acids, it corroded strongly. This is not new, but what is interesting here is that the two objects corroded in a very heterogeneous way. One lead came may be deformed and completely covered with bulky white efflorescences, and the one next to it shows no corrosion.

The "stokar" window, which is of interest here, was restored in 2008, just before it was put on display. The restoration consisted of replacing some of the lead came. Thus, while the object is dated to the 16th century, the replaced came were new when they entered the display case. In 2018, they were completely corroded. In comparison, the other stained glass panel, with older lead came, was placed in the same display case at the same time. For this second panel, the came are slightly corroded in 2018, but not as badly as those of the 'Stokar' panel. The metal chosen by the restorer reacted more strongly with the corrosive environment (the display case) than the historical metal.

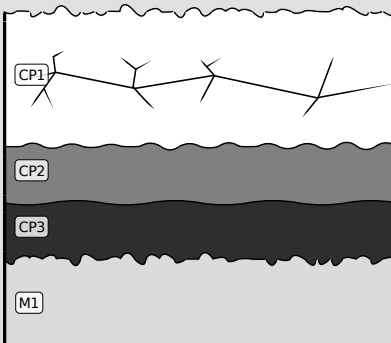
Fig. 4: Stratigraphic representation of the lead came under binocular using the MiCorr application. The characteristics of the strata are only accessible by clicking on the drawing that redirects you to the search tool by stratigraphy representation, Credit HE-Arc CR, A.Gerber.

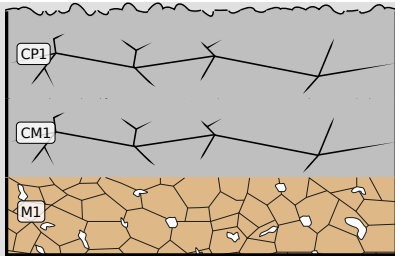
Fig. 10: Stratigraphic representation of the lead came in cross-section (dark field) using the MiCorr application with

reference to Fig. 8. The characteristics of the strata are only accessible by clicking on the drawing that redirects you to the search tool by stratigraphy representation, Credit HE-Arc CR, A.Gerber

Fig. 11 shows an optimised stratigraphic representation of the corrosion structure. It is to be noted that CP1, CP2 and CP3 although visible on some cross-sections (Fig. 9) could not be differentiated by analysis.
