LEAD CAMES OF A STAINED GLASS WINDOW 52583 - UNKNOWN - SWITZERLAND

Artefact name Lead cames of a stained glass window 52583

Authors Alice Gerber. (Haute École Arc Neuchâtel, Neuchâtel, Neuchâtel, Switzerland)

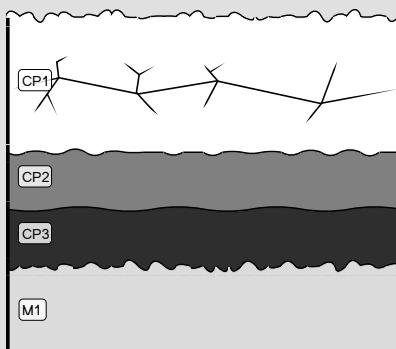
Fig. 4: Stratigraphic representation of the lead came under binocular using the MiCorr application. The characteristics of the strata are only accessible by clicking on the drawing that redirects you to the search tool by stratigraphy representation, Credit HE-Arc CR, A.Gerber.

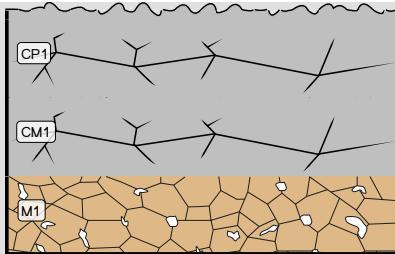
Corrosion develops specifically on cames made of a lead-antimony alloy, where antimony inclusions constitute the cathode (0.150 V/SHE) versus lead (-0.125 V/SHE) which corrodes as an anode in presence of lead acetate (the electrolyte). Fig. 8 shows that corrosion does not attack the antimony nodules in the alloy, it progresses by mineralizing the lead around these nodules.

Fig. 10: Stratigraphic representation of the lead came in cross-section (dark field) using the MiCorr application with reference to Fig. 8. The characteristics of the strata are only accessible by clicking on the drawing that redirects you to the search tool by stratigraphy representation, Credit HE-Arc CR, A.Gerber

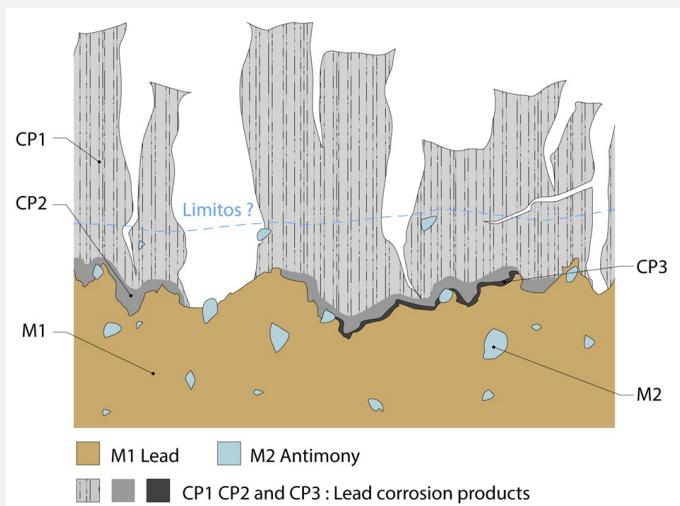
Fig. 11 shows an optimised stratigraphic representation of the corrosion structure. It is to be noted that CP1, CP2 and CP3 although visible on some cross-sections (Fig. 9) could not be differentiated by analysis.

The limit of the original surface lies somewhere in the corrosion layers. Antimony nodules are inferior markers of the limit of the original surface.

Fig. 11: Optimised stratigraphic representation of a corroded lead came integrating additional information based on the analyses carried out,

The lead came is heavily corroded and its original surface contained in the thick and very fragile corrosion layer might get lost easily in case of any physical shock.
