LEAD CAMES OF A STAINED GLASS WINDOW 52583 – UNKNOWN – SWITZERLAND

Artefact name	Lead comes of a stained glass window 52583
Authors	Alice Gerber. (Haute École Arc Neuchâtel, Neuchâtel, Neuchâtel, Switzerland)
Url	/artefacts/884/

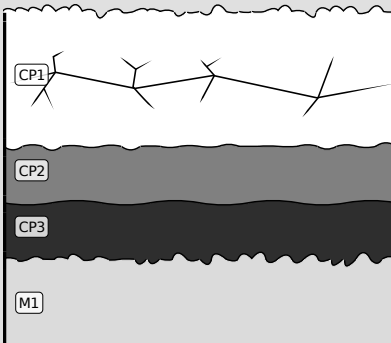
Fig. 4: Stratigraphic representation of the lead came under binocular using the MiCorr application. The characteristics of the strata are only accessible by clicking on the drawing that redirects you to the search tool by stratigraphy representation, Credit HE-Arc CR, A.Gerber.

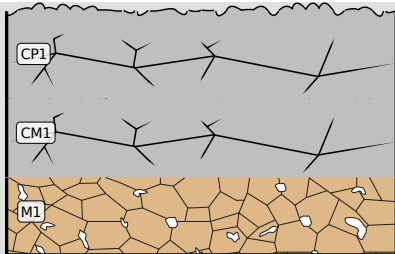
Corrosion develops specifically on comes made of a lead-antimony alloy, where antimony inclusions constitute the cathode (0.150 V/SHE) versus lead (-0.125 V/SHE) which corrodes as an anode in presence of lead acetate (the electrolyte). Fig. 8 shows that corrosion does not attack the antimony nodules in the alloy, it progresses by mineralizing the lead around these nodules.

CP1 seems to be an heterogeneous compound as indicated on Figs. 8 and 9. It is heavily cracked (Fig. 9). EDX analyses do not indicate a significant difference in composition. The attack of lead by organic acids causes the formation of salts, such as lead acetate which are then transformed into basic lead carbonates by the action of CO2 from the environment as indicated by FTIR analysis of CP1.

Fig. 10: Stratigraphic representation of the lead came in cross-section (dark field) using the MiCorr application with

reference to Fig. 8. The characteristics of the strata are only accessible by clicking on the drawing that redirects you to the search tool by stratigraphy representation, Credit HE-Arc CR, A.Gerber

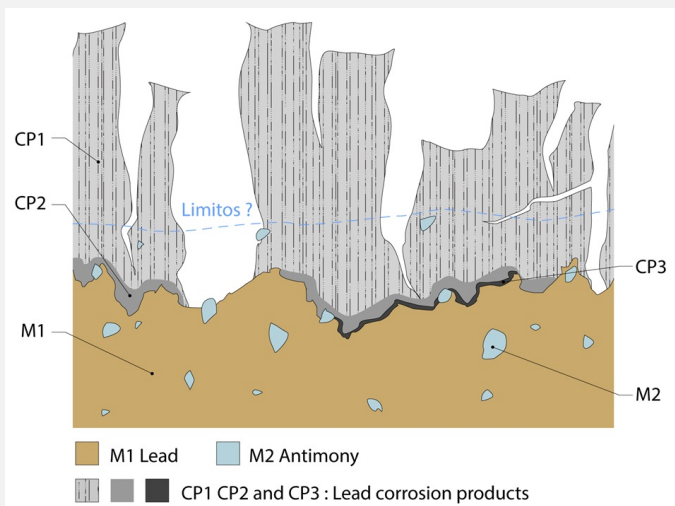
Fig. 11 shows an optimised stratigraphic representation of the corrosion structure. It is to be noted that CP1, CP2 and CP3 although visible on some cross-sections (Fig. 9) could not be differentiated by analysis.

The limit of the original surface lies somewhere in the corrosion layers. Antimony nodules are inferior markers of the limit of the original surface.

Fig. 11: Optimised stratigraphic representation of a corroded lead came integrating additional information based on the analyses carried out,

The lead came is a lead-antimony alloy. Lead is a metal that is very sensitive to organic acids. But it can be alloyed with elements that can either increase its resistance to corrosion (tin) or make it more sensitive to organic acids. Antimony (Sb) is such an element that enhances active corrosion due to the galvanic effect between this element and lead.

The lead came is heavily corroded and its original surface contained in the thick and very fragile corrosion layer might get lost easily in case of any physical shock.
