LEAD CAMES OF A STAINED GLASS WINDOW 52583 – UNKNOWN – SWITZERLAND

Artefact name Lead comes of a stained glass window 52583

Authors Alice Gerber. (Haute École Arc Neuchâtel, Neuchâtel, Neuchâtel, Switzerland)

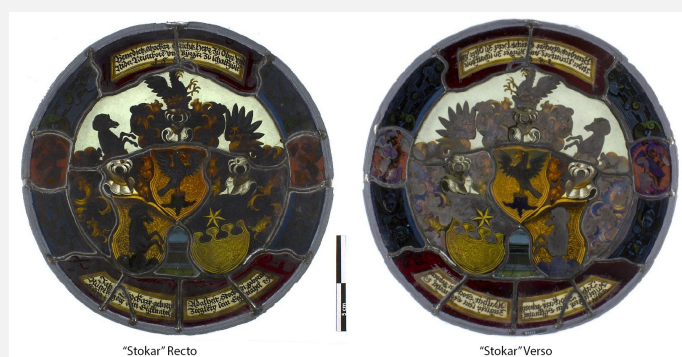
Fig. 1: Stained glass panel "Stokar" both sides,

The object is made of incolor and colored glass (light blue, pink and red) decored with grisaille, silver yellow stain and blue enamel. The glass parts are crimped with lead-alloy comes. The comes are fastened to one another by welding points of a lead-tin alloy on both side of the panel (Fig. 1).

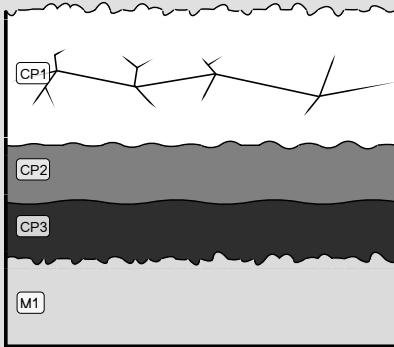
Fig. 4: Stratigraphic representation of the lead came under binocular using the MiCorr application. The characteristics of the strata are only accessible by clicking on the drawing that redirects you to the search tool by stratigraphy representation, Credit HE-Arc CR, A.Gerber.

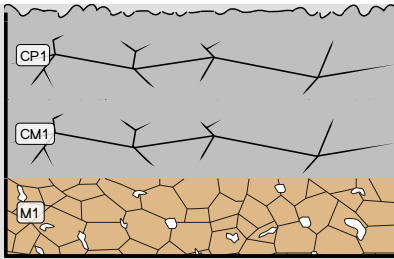
Corrosion develops specifically on comes made of a lead-antimony alloy, where antimony inclusions constitute the cathode (0.150 V/SHE) versus lead (-0.125 V/SHE) which corrodes as an anode in presence of lead acetate (the electrolyte). Fig. 8 shows that corrosion does not attack the antimony nodules in the alloy, it progresses by mineralizing the lead around these nodules.

CP1 seems to be a heterogeneous compound as indicated on Figs. 8 and 9. It is heavily cracked (Fig. 9). EDX analyses do not indicate a significant difference in composition. The attack of lead by organic acids causes the formation of salts, such as lead acetate which are then transformed into basic lead carbonates by the action of CO₂ from the environment as indicated by FTIR analysis of CP1.

Fig. 10: Stratigraphic representation of the lead came in cross-section (dark field) using the MiCorr application with reference to Fig. 8. The characteristics of the strata are only accessible by clicking on the drawing that redirects you to the search tool by stratigraphy representation, Credit HE-Arc CR, A.Gerber

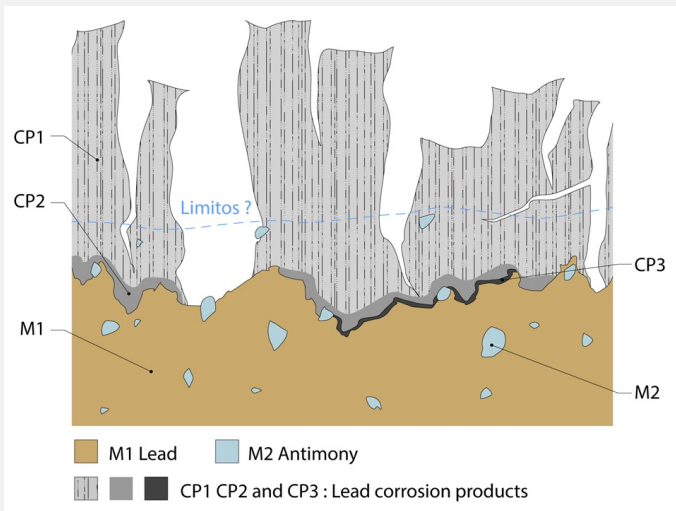
Fig. 11 shows an optimised stratigraphic representation of the corrosion structure. It is to be noted that CP1, CP2 and CP3 although visible on some cross-sections (Fig. 9) could not be differentiated by analysis. The limit of the original surface lies somewhere in the corrosion layers. Antimony nodules are inferior markers of the limit of the original surface.

Fig. 11: Optimised stratigraphic representation of a corroded lead came integrating additional information based on the analyses carried out,
