# LEAD CAMES OF A STAINED GLASS WINDOW 52583 – UNKNOWN – SWITZERLAND

**Artefact name** Lead comes of a stained glass window 52583

**Authors** Alice Gerber. (Haute École Arc Neuchâtel, Neuchâtel, Neuchâtel, Switzerland)

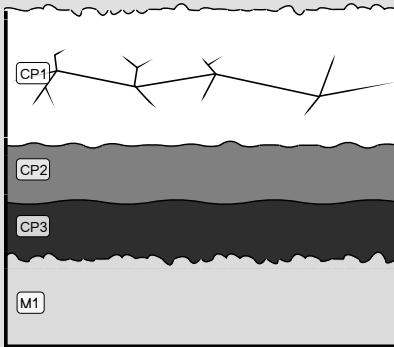
Fig. 4: Stratigraphic representation of the lead came under binocular using the MiCorr application. The characteristics of the strata are only accessible by clicking on the drawing that redirects you to the search tool by stratigraphy representation, Credit HE-Arc CR, A.Gerber.

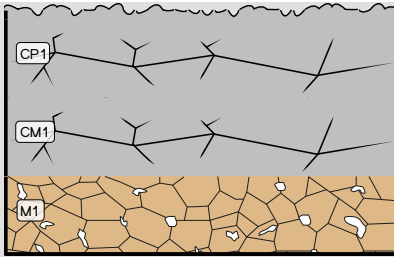
Corrosion develops specifically on comes made of a lead-antimony alloy, where antimony inclusions constitute the cathode (0.150 V/SHE) versus lead (-0.125 V/SHE) which corrodes as an anode in presence of lead acetate (the electrolyte). Fig. 8 shows that corrosion does not attack the antimony nodules in the alloy, it progresses by mineralizing the lead around these nodules.

Fig. 10: Stratigraphic representation of the lead came in cross-section (dark field) using the MiCorr application with reference to Fig. 8. The characteristics of the strata are only accessible by clicking on the drawing that redirects you to the search tool by stratigraphy representation, Credit HE-Arc CR, A.Gerber
