HISPANO-SUIZA WATER PUMP - AL ALLOY - FRANCE

Artefact name Hispano-Suiza water pump

Authors Christian. Degrigny (HE-Arc CR, Neuchâtel, Neuchâtel, Switzerland) & Elodie. Granget (HE-Arc CR, Neuchâtel, Neuchâtel, Switzerland) & Brice. Chalançon (MNAM (Musée National de l'Automobile de Mulhouse), Mulhouse, Alsace, France)

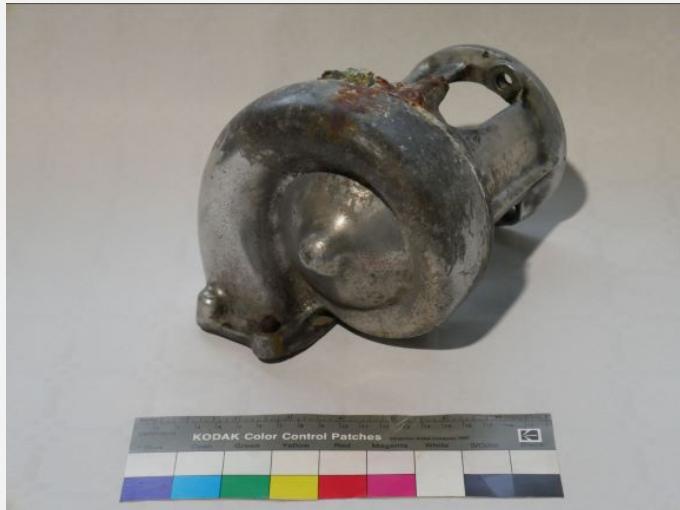
This Hispano-Suiza water pump (Fig. 1), measuring around 15x15x20 cm, is made of 3 parts (Fig. 2):

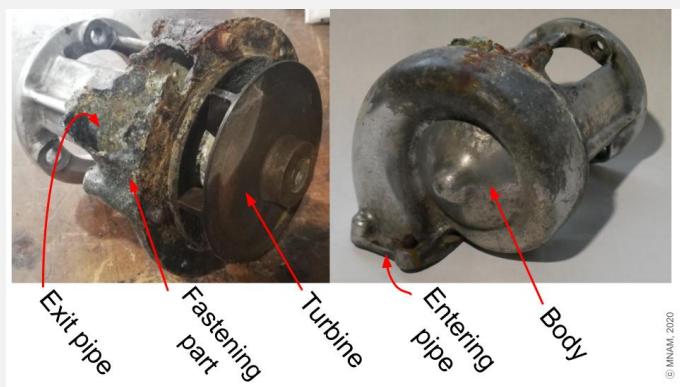
- > A body (or cover), shaped like a snail, containing the entering pipe,
- > A turbine, inside the pump, connected through the fastening part to a rotating shaft of the engine,
- > A fastening part, screwed on the body with steel screws and brass gasket-rings containing the exit pipe.

The exit pipe of the fastening part considered within this study is heavily corroded.

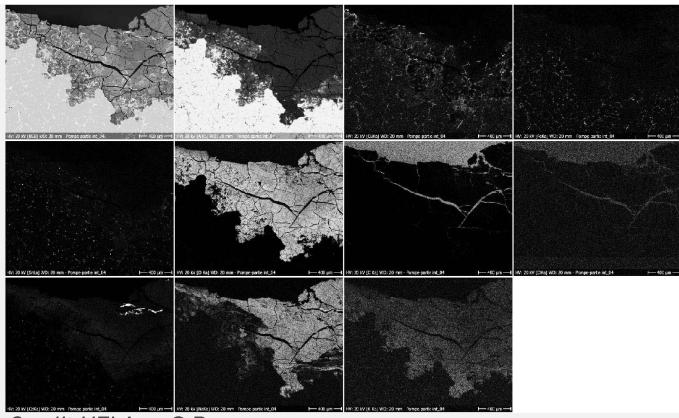
The SEM image of Fig. 11 clearly shows a network of cracks throughout CM1 and CPs. These cracks are not marking any clear separation between strata, but seem to affect all corrosion layers. The main Al phase is preferentially oxidized, while the interdendritic phase seems to be preserved in the corrosion products (Figs. 11 to 13). Na and K but no Fe are detected in the corrosion layers CM1 and CPs (Fig. 14). This surface is in contact with the coolant (glycol + additives, usually mixed 1/1 in water), which sometimes contain Na or K-based corrosion inhibitors. A cluster of CaCO₃ was identified on the very surface of the sample (Fig. 15). CaCO₃ can sometimes precipitate if the water used to mix the coolant is hard.

Fig. 13: Sn (red), Fe (blue) and Cu (green) distribution of the area of Fig. 11. Method of analysis: SEM-EDS. Lab. of Electronic Microscopy and Microanalysis, Néode, HEI Arc,

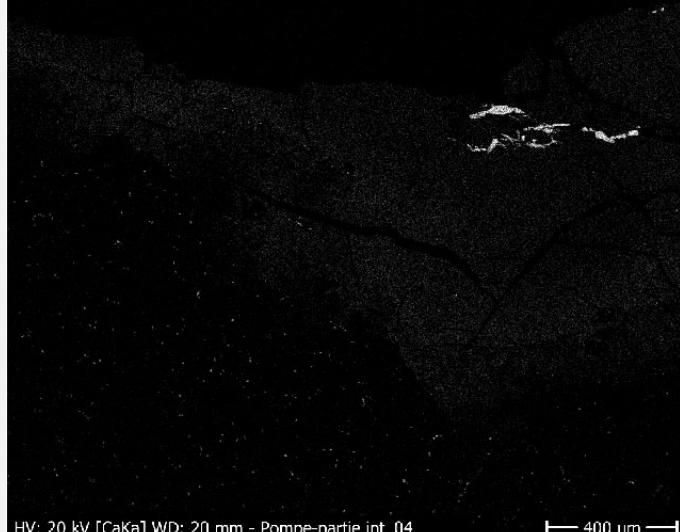
Fig. 14: SEM image and elemental chemical distribution of the area of Fig. 11. Method of analysis: SEM-EDS. Lab. of Electronic Microscopy and Microanalysis, Néode, HEI Arc,
