HISPANO-SUIZA WATER PUMP – AL ALLOY – FRANCE

Artefact name Hispano-Suiza water pump

Authors Christian. Degriigny (HE-Arc CR, Neuchâtel, Neuchâtel, Switzerland) & Elodie. Granget (HE-Arc CR, Neuchâtel, Neuchâtel, Switzerland) & Brice. Chalançon (MNAM (Musée National de l'Automobile de Mulhouse), Mulhouse, Alsace, France)

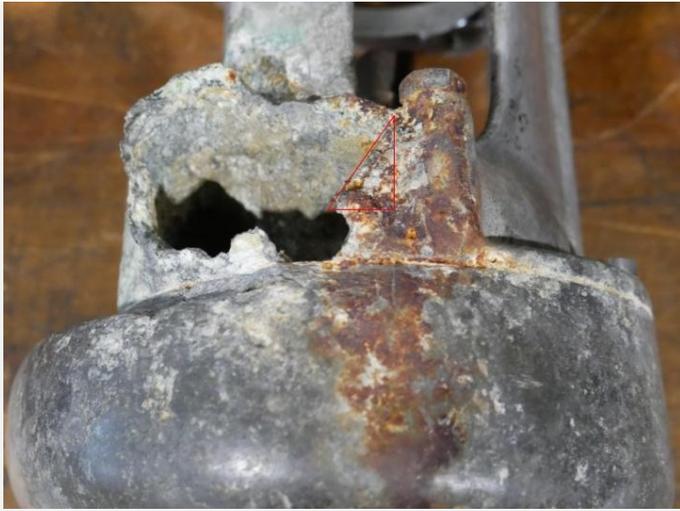
The exit pipe of the fastening part considered within this study is heavily corroded.

Fig. 3: Location of sampling area on the Hispano water pump,

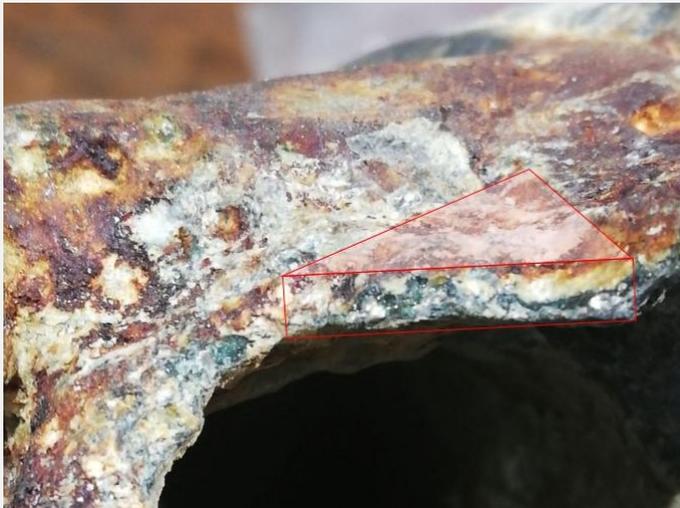
Fig. 4: Close-up view of the Hispano water pump, with the exit pipe sampling area,

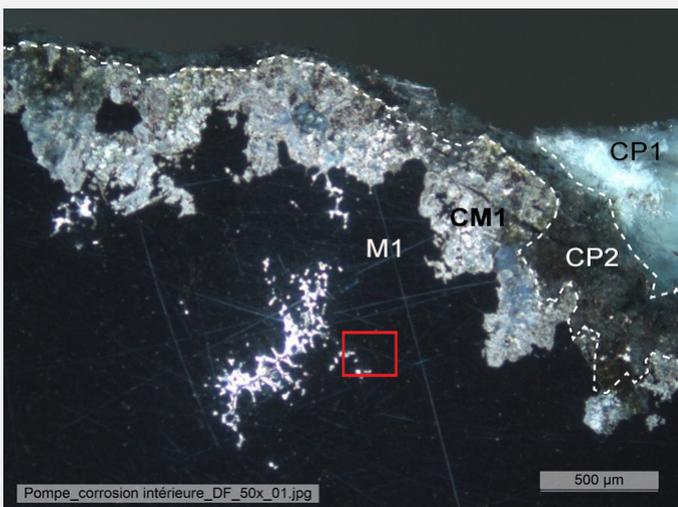
The porosity of this aluminium-copper alloy (Table 1) has been confirmed by optical (Figs. 8 and 9) and SEM observations on the cross-section of the fastening part's fragment (Fig. 10). The metal has a dendritic microstructure (Fig. 10).

Fig. 8: Micrograph of the selected area (in red) of the sample shown on Fig. 7, unetched, dark field with location of Fig. 10,

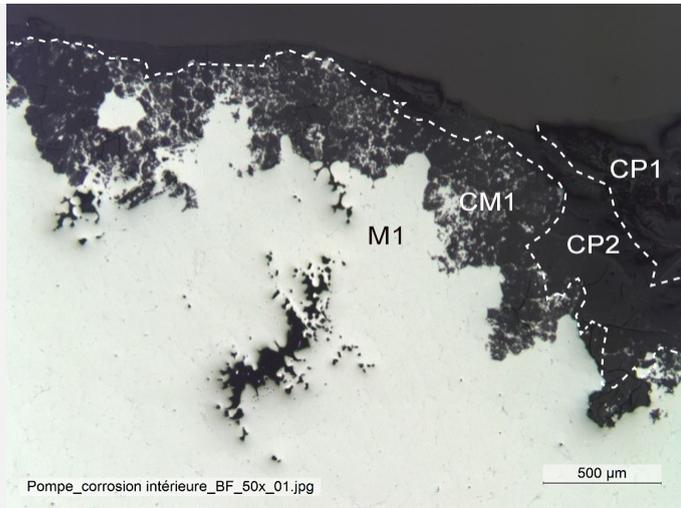
Fig. 9: Micrograph similar to Fig. 8, unetched, bright field,

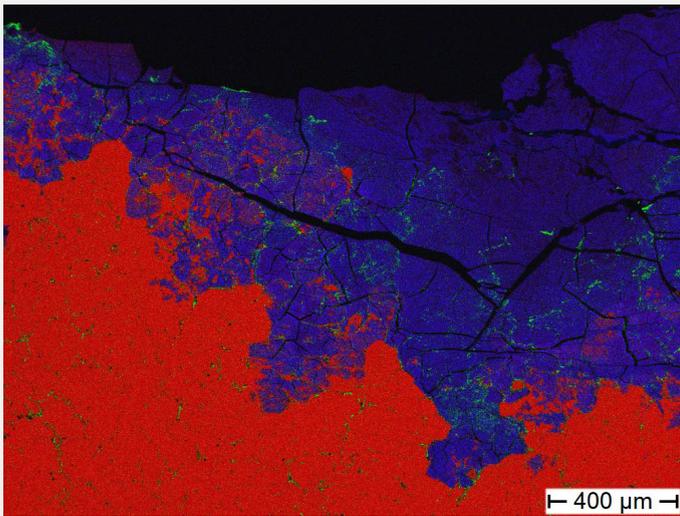
Local analyses on each phase appearing on Fig. 10 showed that the main phase is composed of Al and the interdendritic phases are composed of Al, Cu and Fe as well as Sn precipitates. This distribution is given through EDS elemental chemical distributions (Figs. 12 to 14).

Fig. 12: Al (red), O (blue) and Cu (green) distribution of the area of Fig. 11. Method of analysis: SEM-EDS. Lab. of Electronic Microscopy and Microanalysis, Néode, HEI Arc,

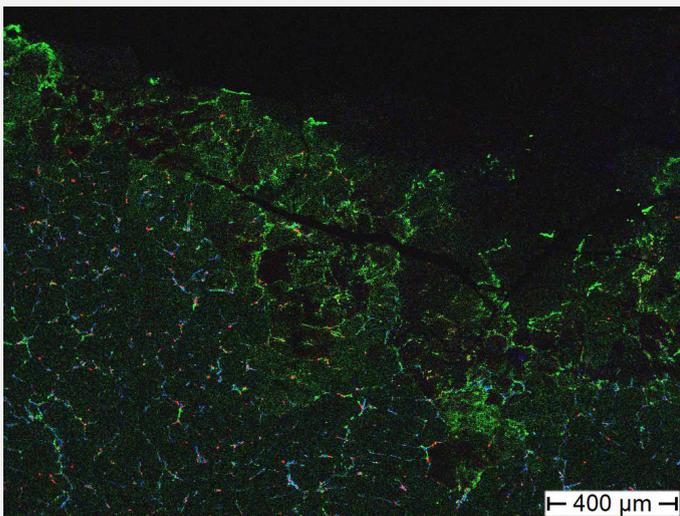
Fig. 13: Sn (red), Fe (blue) and Cu (green) distribution of the area of Fig. 11. Method of analysis: SEM-EDS. Lab. of Electronic Microscopy and Microanalysis, Néode, HEI Arc,

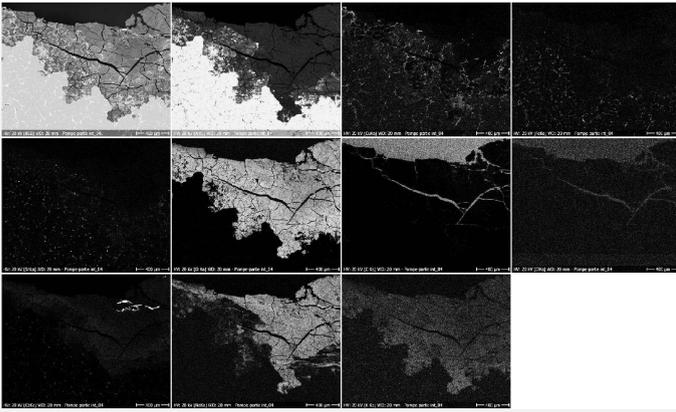
Fig. 14: SEM image and elemental chemical distribution of the area of Fig. 11. Method of analysis: SEM-EDS. Lab. of Electronic Microscopy and Microanalysis, Néode, HEI Arc,

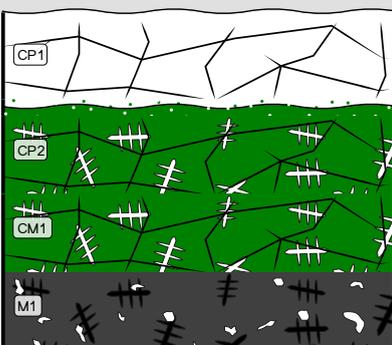
Fig. 16: Stratigraphic representation of the sample taken from the fastening part of the Hispano water pump in cross-section (dark field) using the MiCorr application. The characteristics of the strata are only accessible by clicking on the drawing that redirects you to the search tool by stratigraphy representation. This representation can be compared to Fig. 9, Credit HE-Arc CR, E.Granget.
