BUGATTI COOLING SYSTEM PIPE – AL ALLOY – UNKNOWN – FRANCE

Artefact name	Bugatti cooling system pipe
Authors	Christian. Degriigny (HE-Arc CR, Neuchâtel, Neuchâtel, Switzerland) & Elodie. Granget (HE-Arc CR, Neuchâtel, Neuchâtel, Switzerland) & Brice. Chalançon (MNAM (Musée National de l'Automobile de Mulhouse), Mulhouse, Alsace, France)
Url	/artefacts/888/

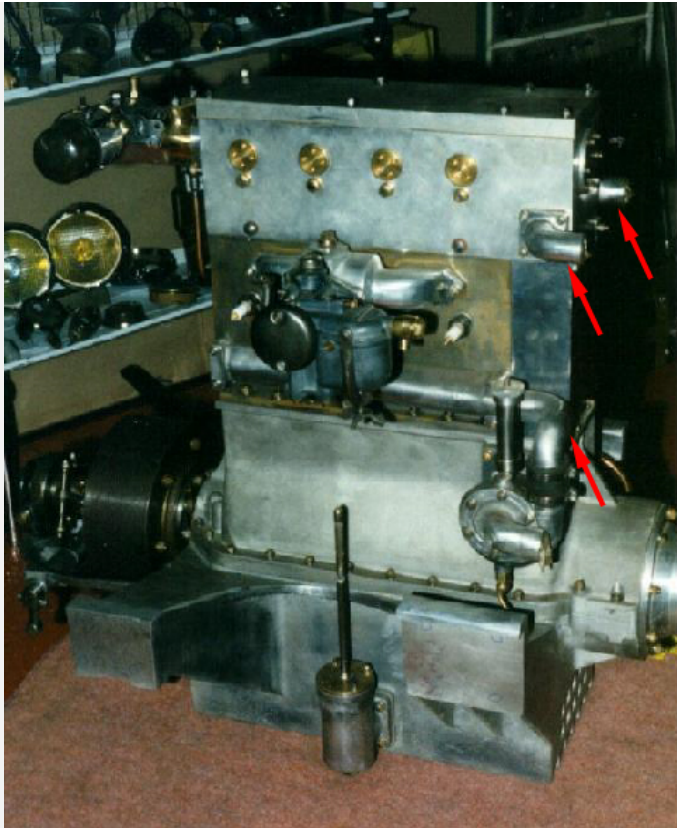
Fig. 2: Examples of water pipes located on a Type 37 engine,

A combustion engine transforms thermal energy into kinetic energy. This process is imperfect and releases a lot of heat through the block of the engine. Therefore, these parts need to be cooled down. A cooling system circulating water between the block [hot] and a heat exchanger (or radiator) [cold] is frequently used to fulfill this function (Poulain, 1995, p.86). Most of the time, the Bugatti inline cylinder engines have aluminium water pipes entering the block from below and exiting it from above, as shown on Fig.2.

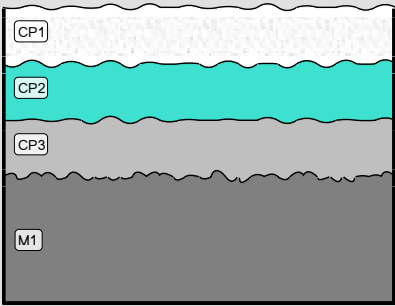
The stratum M is an aluminium alloy. Three CP strata have been identified. CP3 has a greyish mate color and is covering all of the corroded side of the pipe. Scattered over this uniform layer, blue-green (CP2) and white (CP1) spots of corrosion products can be found.

Fig. 5: Stratigraphic representation of the Bugatti water pipe observed macroscopically under binocular using the MiCorr application. The characteristics of the strata are only accessible by clicking on the drawing that redirects you to the search tool by stratigraphy representation. This representation can be compared to Fig. 4, Credit HE-Arc CR, E.Granget.

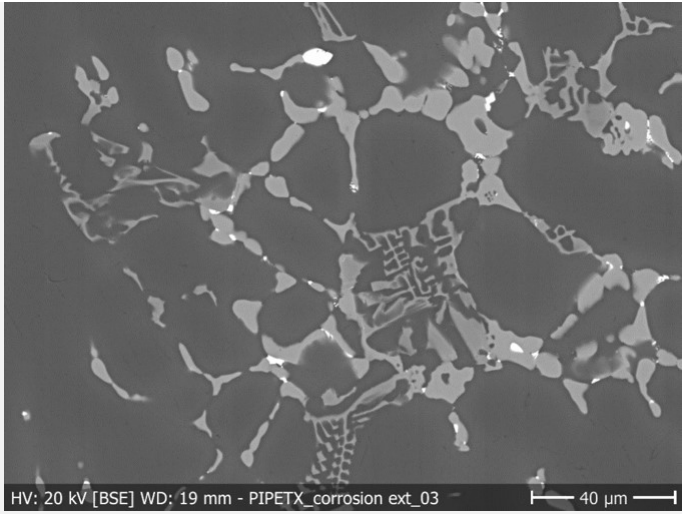
The metal is an aluminium alloy containing both Cu and Zn. It is slightly porous (Fig. 7, red circles). Its dendritic microstructure is revealed by observation in bright field (Fig. 8) and with SEM (Fig. 9).

Fig. 9: SEM image (BSE mode) of the metal sample from Fig. 8 showing the microstructure of the pipe. Dark grey = main phase (Al), medium grey = interdendritic phase 1 (eutectic Al, Fe, Cu), light grey = interdendritic phase 2 (Al, Cu) and white = precipitates (Si, Sn),

This angled water pipe, coming from a Bugatti engine's cooling system, is made of cast Al, Cu, Zn, Fe alloy and shows a slightly porous dendritic microstructure. There are two interdendritic phases, a eutectic Al, Fe, Cu phase and a Al, Cu phase, as well as precipitates of Si and Sn.

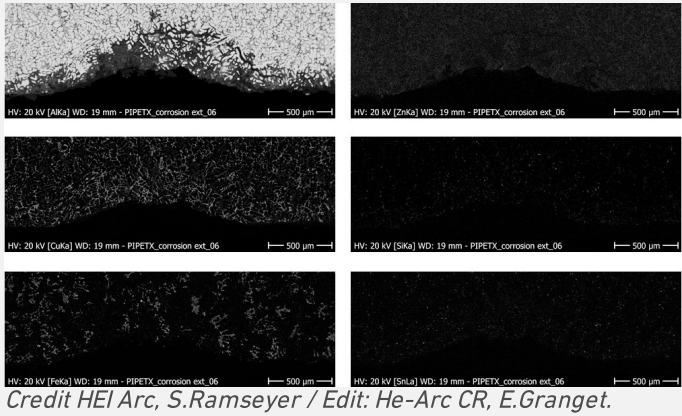
Fig. 10: Close-up image of Fig. 9,

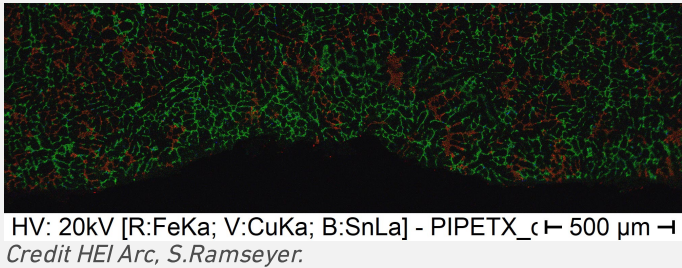
Zn is uniformly present in the alloy. There are two interdendritic phases (Fig. 12): a eutectic phase containing Al, Fe and Cu, and a second phase containing mostly Al, Cu. Additionally Sn and Si precipitates could be identified.

Fig. 11: SEM image and EDS elemental chemical distribution of main and interdendritic phases of the pipe. 20kV,

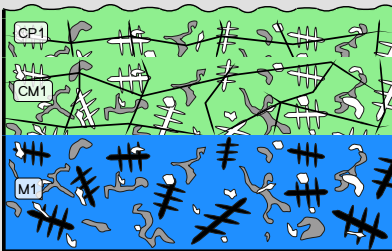
The BF and DF images (Figs. 7 and 8) show a few big cracks at the interface between CM1 and M1. The SEM image shows that they expand in a network of additional microcracks (Fig. 13). The pipe suffers from a uniform interdendritic corrosion. The Al, Cu and Zn phase is oxidising preferentially, developing then aluminium oxides, versus the interdendritic phases. In some places, pits of corrosion formed. SEM cartography showed a concentration of Cl at the base of the pit (Fig. 14: Green).

Fig. 14: Stratigraphic representation of the sample taken from the Bugatti water pipe in cross-section (dark field) using the MiCorr application. The characteristics of the strata are only accessible by clicking on the drawing that redirects you to the search tool by stratigraphy representation. This representation can be compared to Fig. 7 and 8, Credit HE-Arc CR, E.Granget.

The external surface shows a uniform interdendritic corrosion preferentially consuming the dendritic phase (Al, Cu, Zn). Pitting corrosion has been identified, with Cl pockets at the base of the pit.
