## BUGATTI COOLING SYSTEM PIPE – AL ALLOY – UNKNOWN – FRANCE

**Artefact name** Bugatti cooling system pipe

**Authors** Christian. Degriigny (HE-Arc CR, Neuchâtel, Neuchâtel, Switzerland) & Elodie. Granget (HE-Arc CR, Neuchâtel, Neuchâtel, Switzerland) & Brice. Chalanson (MNAM (Musée National de l'Automobile de Mulhouse), Mulhouse, Alsace, France)

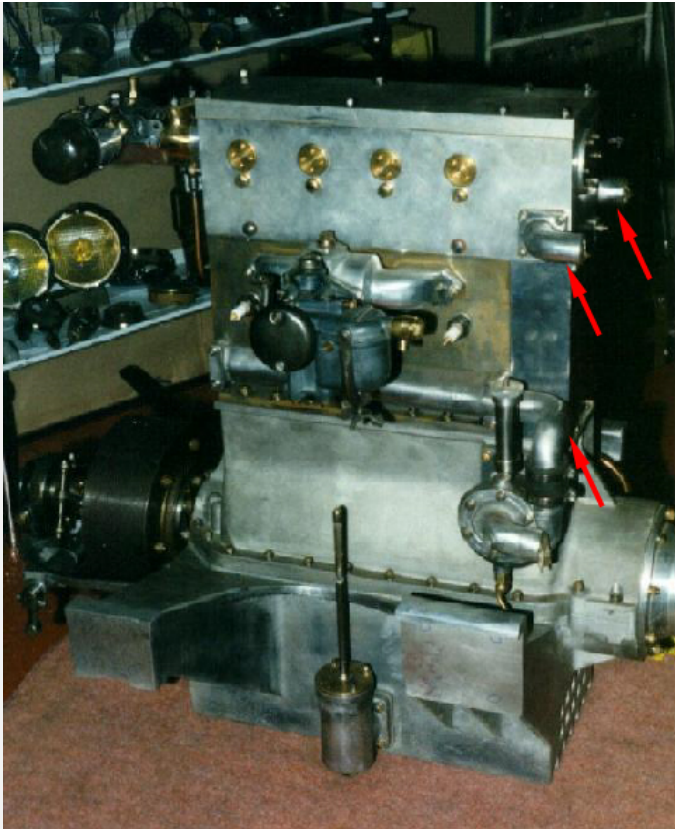
Fig. 2: Examples of water pipes located on a Type 37 engine,

A combustion engine transforms thermal energy into kinetic energy. This process is imperfect and releases a lot of heat through the block of the engine. Therefore, these parts need to be cooled down. A cooling system circulating water between the block [hot] and a heat exchanger (or radiator) [cold] is frequently used to fulfill this function (Poulain, 1995, p.86). Most of the time, the Bugatti inline cylinder engines have aluminium water pipes entering the block from below and exiting it from above, as shown on Fig.2.

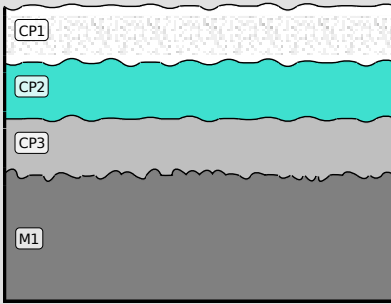
The stratum M is an aluminium alloy. Three CP strata have been identified. CP3 has a greyish mate color and is covering all of the corroded side of the pipe. Scattered over this uniform layer, blue-green (CP2) and white (CP1) spots of corrosion products can be found.

Fig. 5: Stratigraphic representation of the Bugatti water pipe observed macroscopically under binocular using the MiCorr application. The characteristics of the strata are only accessible by clicking on the drawing that redirects you to the search tool by stratigraphy representation. This representation can be compared to Fig. 4, Credit HE-Arc CR, E.Granget.

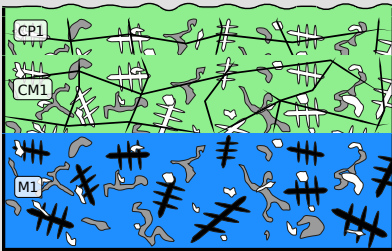
Fig. 14: Stratigraphic representation of the sample taken from the Bugatti water pipe in cross-section (dark field) using the MiCorr application. The characteristics of the strata are only accessible by clicking on the drawing that redirects you to the search tool by stratigraphy representation. This representation can be compared to Fig. 7 and 8, Credit HE-Arc CR, E.Granget.
