BUGATTI COOLING SYSTEM PIPE - AL ALLOY - UNKNOWN - FRANCE

Artefact name Bugatti cooling system pipe

Authors Christian. Degrigny (HE-Arc CR, Neuchâtel, Neuchâtel, Switzerland) & Elodie. Granget (HE-Arc CR, Neuchâtel, Neuchâtel, Switzerland) & Brice. Chalauçon (MNAM (Musée National de l'Automobile de Mulhouse), Mulhouse, Alsace, France)

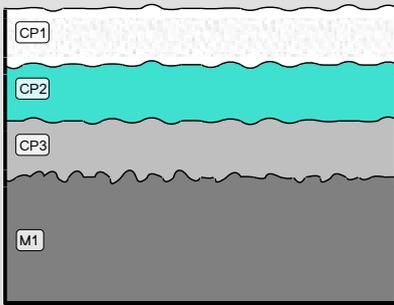
The stratum M is an aluminium alloy. Three CP strata have been identified. CP3 has a greyish mate color and is covering all of the corroded side of the pipe. Scattered over this uniform layer, blue-green (CP2) and white (CP1) spots of corrosion products can be found.

Fig. 5: Stratigraphic representation of the Bugatti water pipe observed macroscopically under binocular using the MiCorr application. The characteristics of the strata are only accessible by clicking on the drawing that redirects you to the search tool by stratigraphy representation. This representation can be compared to Fig. 4, Credit HE-Arc CR, E.Granget.

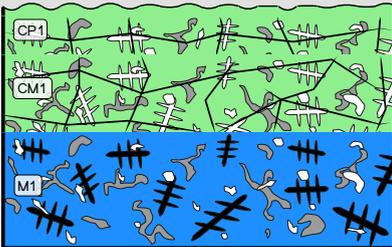
The BF and DF images (Figs. 7 and 8) show a few big cracks at the interface between CM1 and M1. The SEM image shows that they expand in a network of additional microcracks (Fig. 13). The pipe suffers from a uniform interdendritic corrosion. The Al, Cu and Zn phase is oxidising preferentially, developing then aluminium oxides, versus the interdendritic phases. In some places, pits of corrosion formed. SEM cartography showed a concentration of Cl at the base of the pit (Fig. 14: Green).

Fig. 14: Stratigraphic representation of the sample taken from the Bugatti water pipe in cross-section (dark field) using the MiCorr application. The characteristics of the strata are only accessible by clicking on the drawing that redirects you to the search tool by stratigraphy representation. This representation can be compared to Fig. 7 and 8, Credit HE-Arc CR, E.Granget.

The external surface shows a uniform interdendritic corrosion preferentially consuming the dendritic phase (Al, Cu, Zn). Pitting corrosion has been identified, with Cl pockets at the base of the pit.
