## BUGATTI COOLING SYSTEM PIPE – AL ALLOY – UNKNOWN – FRANCE

**Artefact name** Bugatti cooling system pipe

**Authors** Christian. Degriigny (HE-Arc CR, Neuchâtel, Neuchâtel, Switzerland) & Elodie. Granget (HE-Arc CR, Neuchâtel, Neuchâtel, Switzerland) & Brice. Chalanson (MNAM (Musée National de l'Automobile de Mulhouse), Mulhouse, Alsace, France)

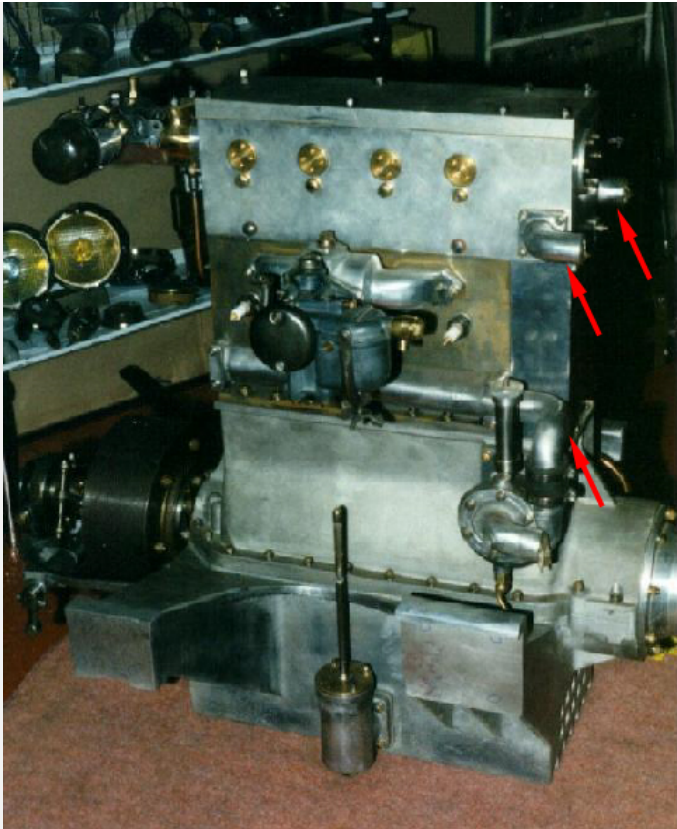
Fig. 2: Examples of water pipes located on a Type 37 engine,

A combustion engine transforms thermal energy into kinetic energy. This process is imperfect and releases a lot of heat through the block of the engine. Therefore, these parts need to be cooled down. A cooling system circulating water between the block [hot] and a heat exchanger (or radiator) [cold] is frequently used to fulfill this function (Poulain, 1995, p.86). Most of the time, the Bugatti inline cylinder engines have aluminium water pipes entering the block from below and exiting it from above, as shown on Fig.2.

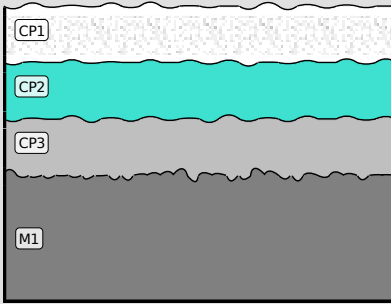
The stratum M is an aluminium alloy. Three CP strata have been identified. CP3 has a greyish mate color and is covering all of the corroded side of the pipe. Scattered over this uniform layer, blue-green (CP2) and white (CP1) spots of corrosion products can be found.

Fig. 5: Stratigraphic representation of the Bugatti water pipe observed macroscopically under binocular using the MiCorr application. The characteristics of the strata are only accessible by clicking on the drawing that redirects you to the search tool by stratigraphy representation. This representation can be compared to Fig. 4, Credit HE-Arc CR, E.Granget.

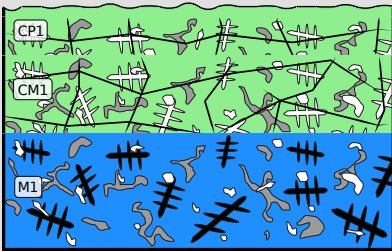
The BF and DF images (Figs. 7 and 8) show a few big cracks at the interface between CM1 and M1. The SEM image shows that they expand in a network of additional microcracks (Fig. 13). The pipe suffers from a uniform interdendritic corrosion. The Al, Cu and Zn phase is oxidising preferentially, developing then aluminium oxides, versus the interdendritic phases. In some places, pits of corrosion formed. SEM cartography showed a concentration of Cl at the base of the pit (Fig. 14: Green).

Fig. 14: Stratigraphic representation of the sample taken from the Bugatti water pipe in cross-section (dark field) using the MiCorr application. The characteristics of the strata are only accessible by clicking on the drawing that redirects you to the search tool by stratigraphy representation. This representation can be compared to Fig. 7 and 8, Credit HE-Arc CR, E.Granget.
