BUGATTI COOLING SYSTEM PIPE – AL ALLOY – UNKNOWN – FRANCE

Artefact name Bugatti cooling system pipe

Authors Christian. Degriigny (HE-Arc CR, Neuchâtel, Neuchâtel, Switzerland) & Elodie. Granget (HE-Arc CR, Neuchâtel, Neuchâtel, Switzerland) & Brice. Chalançon (MNAM (Musée National de l'Automobile de Mulhouse), Mulhouse, Alsace, France)

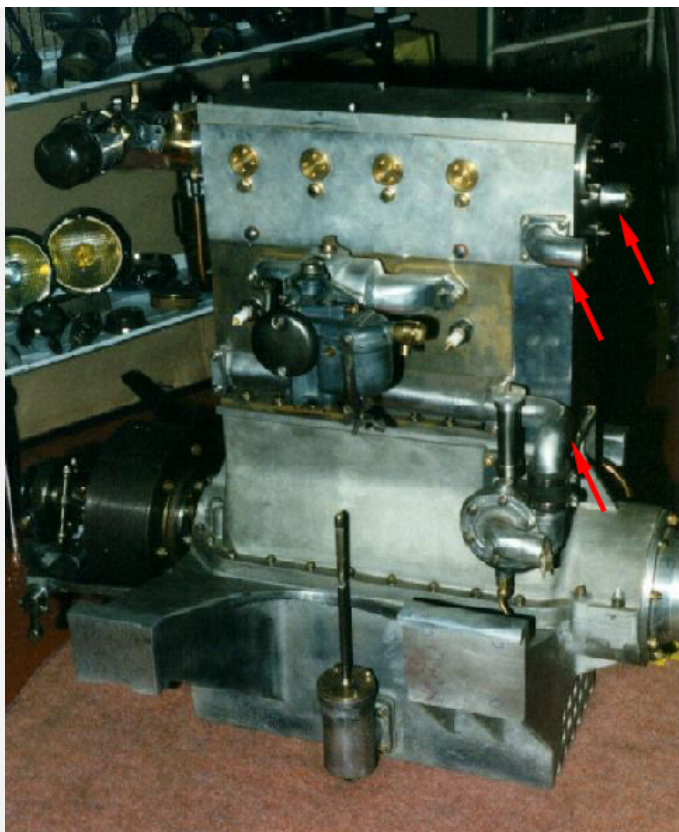
Fig. 2: Examples of water pipes located on a Type 37 engine,

A combustion engine transforms thermal energy into kinetic energy. This process is imperfect and releases a lot of heat through the block of the engine. Therefore, these parts need to be cooled down. A cooling system circulating water between the block [hot] and a heat exchanger (or radiator) [cold] is frequently used to fulfill this function (Poulain, 1995, p.86). Most of the time, the Bugatti inline cylinder engines have aluminium water pipes entering the block from below and exiting it from above, as shown on Fig.2.

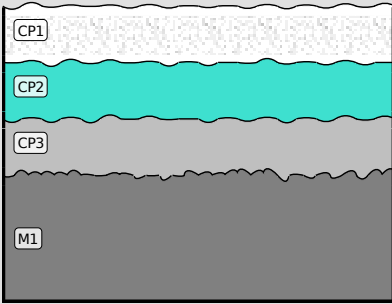
The stratum M is an aluminium alloy. Three CP strata have been identified. CP3 has a greyish mate color and is covering all of the corroded side of the pipe. Scattered over this uniform layer, blue-green (CP2) and white (CP1) spots of corrosion products can be found.

Fig. 5: Stratigraphic representation of the Bugatti water pipe observed macroscopically under binocular using the MiCorr application. The characteristics of the strata are only accessible by clicking on the drawing that redirects you to the search tool by stratigraphy representation. This representation can be compared to Fig. 4, Credit HE-Arc CR, E.Granget.

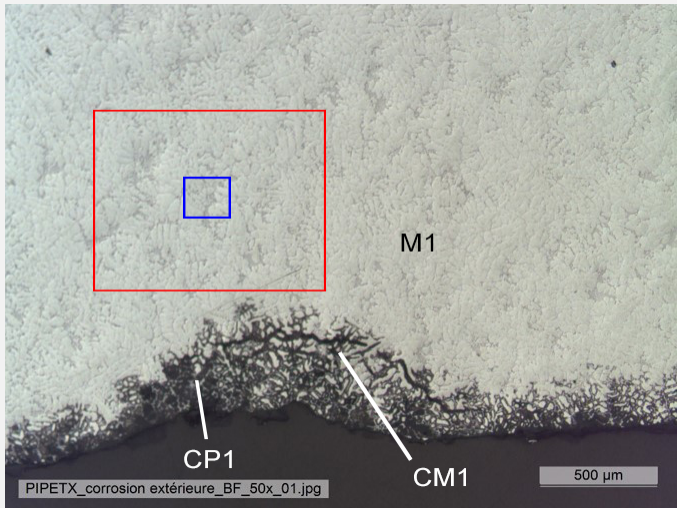
The metal is an aluminium alloy containing both Cu and Zn. It is slightly porous (Fig. 7, red circles). Its dendritic microstructure is revealed by observation in bright field (Fig. 8) and with SEM (Fig. 9).

Fig. 7: Micrograph of the selected area shown on Fig.6 (rotated by 90°), unetched, dark field with indication of pores (red circles),

The BF and DF images (Figs. 7 and 8) show a few big cracks at the interface between CM1 and M1. The SEM image shows that they expand in a network of additional microcracks (Fig. 13). The pipe suffers from a uniform interdendritic corrosion. The Al, Cu and Zn phase is oxidising preferentially, developing then aluminium oxides, versus the interdendritic phases. In some places, pits of corrosion formed. SEM cartography showed a concentration of Cl at the base of the pit (Fig. 14: Green).

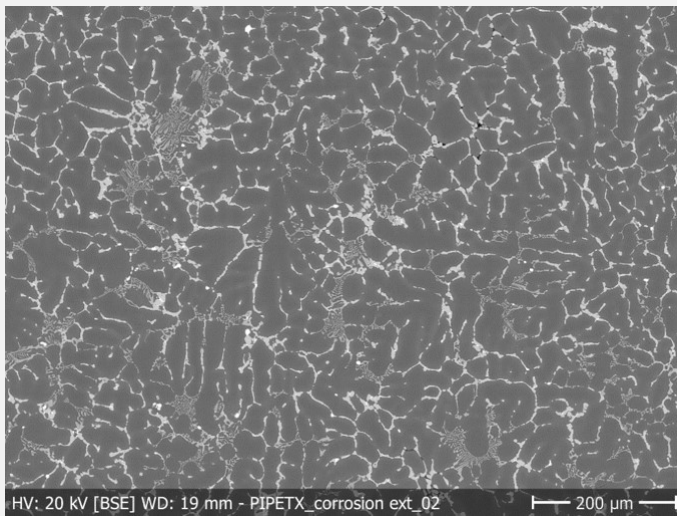
Fig. 8: Micrograph similar to Fig. 7, unetched, bright field showing the locations of Fig. 9 (in red) and Fig. 10 (in blue),

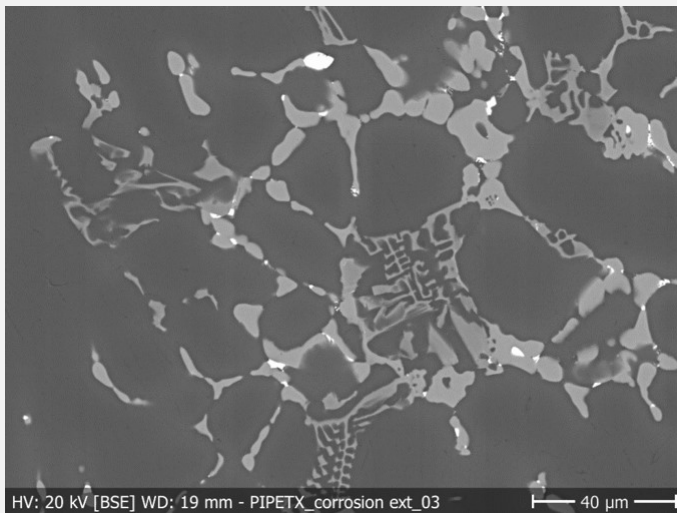
Fig. 9: SEM image (BSE mode) of the metal sample from Fig. 8 showing the microstructure of the pipe. Dark grey = main phase (Al), medium grey = interdendritic phase 1 (eutectic Al, Fe, Cu), light grey = interdendritic phase 2 (Al, Cu) and white = precipitates (Si, Sn),

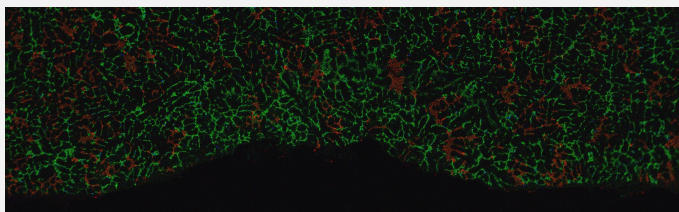
Fig. 11: SEM image and EDS elemental chemical distribution of main and interdendritic phases of the pipe. 20kV,

Fig. 12: Fe (red), Cu (green) and Sn (blue) chemical distribution of the area of Fig. 8. Method of analysis: SEM-EDS. Lab. of Electronic Microscopy and Microanalysis, Néode, HEI Arc,

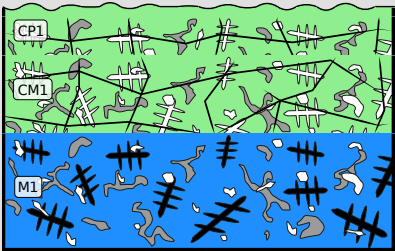
Fig. 14: Stratigraphic representation of the sample taken from the Bugatti water pipe in cross-section (dark field) using the MiCorr application. The characteristics of the strata are only accessible by clicking on the drawing that redirects you to the search tool by stratigraphy representation. This representation can be compared to Fig. 7 and 8, Credit HE-Arc CR, E.Granget.
