## BUGATTI COOLING SYSTEM PIPE – AL ALLOY – UNKNOWN – FRANCE

**Artefact name** Bugatti cooling system pipe

**Authors** Christian. Degriigny (HE-Arc CR, Neuchâtel, Neuchâtel, Switzerland) & Elodie. Granget (HE-Arc CR, Neuchâtel, Neuchâtel, Switzerland) & Brice. Chalançon (MNAM (Musée National de l'Automobile de Mulhouse), Mulhouse, Alsace, France)

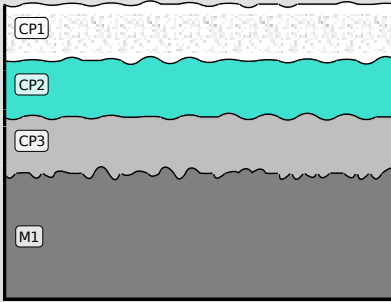
The stratum M is an aluminium alloy. Three CP strata have been identified. CP3 has a greyish mate color and is covering all of the corroded side of the pipe. Scattered over this uniform layer, blue-green (CP2) and white (CP1) spots of corrosion products can be found.

Fig. 5: Stratigraphic representation of the Bugatti water pipe observed macroscopically under binocular using the MiCorr application. The characteristics of the strata are only accessible by clicking on the drawing that redirects you to the search tool by stratigraphy representation. This representation can be compared to Fig. 4, Credit HE-Arc CR, E.Granget.

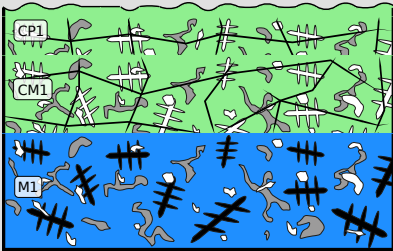
The BF and DF images (Figs. 7 and 8) show a few big cracks at the interface between CM1 and M1. The SEM image shows that they expand in a network of additional microcracks (Fig. 13). The pipe suffers from a uniform interdendritic corrosion. The Al, Cu and Zn phase is oxidising preferentially, developing then aluminium oxides, versus the interdendritic phases. In some places, pits of corrosion formed. SEM cartography showed a concentration of Cl at the base of the pit (Fig. 14: Green).

Fig. 14: Stratigraphic representation of the sample taken from the Bugatti water pipe in cross-section (dark field) using the MiCorr application. The characteristics of the strata are only accessible by clicking on the drawing that redirects you to the search tool by stratigraphy representation. This representation can be compared to Fig. 7 and 8, Credit HE-Arc CR, E.Granget.
