SITULA EMT09-554.665 - TIN BRONZE - IRON AGE - SWITZERLAND

Situla EMT09-554.665

Christian. Degrigny (HE-Arc CR, Neuchâtel, Neuchâtel, Switzerland) & Marie-Jeanne. Scholl (HE-Arc CR, Neuchâtel, Neuchâtel, Switzerland) & Valentin. Boissonnas (HE-Arc CR, Neuchâtel, Neuchâtel, Switzerland)

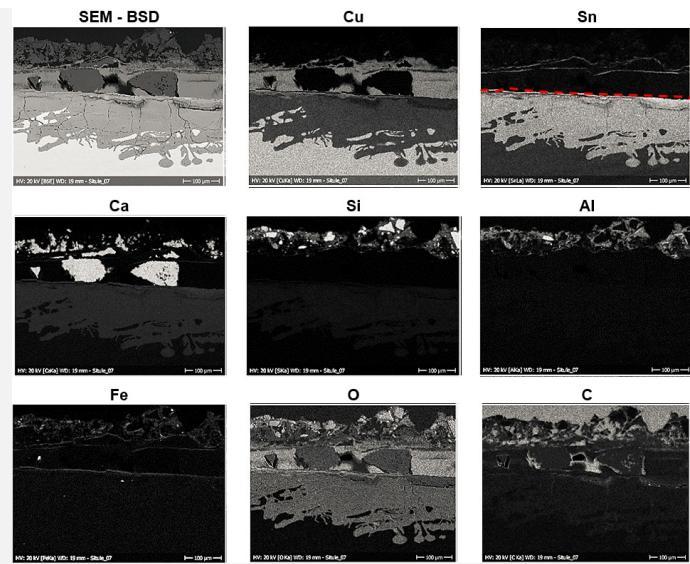
The limit of the original surface is well defined (interface of CP1 and CP2) but due to the fragility of the inner corrosion layers it was difficult to uncover.

Fig. 10: Micrograph of the metal / corrosion interface (detail of Fig. 8) unetched, dark field, 100x. The outer layer (CP1 of Fig. 15) incorporates soil material and the thin dark layer (CP2 of Fig. 15) highlights the limit of the original surface,
