SHOE NAIL 2637 1370.B. – HYPOEUTECTOID STEEL – ROMAN TIMES – SWITZERLAND

Artefact name	Shoe nail 2637 1370.B.
Authors	Christian. Degriigny (HE-Arc CR, Neuchâtel, Neuchâtel, Switzerland) & Valentin. Boissonnas (HE-Arc CR, Neuchâtel, Neuchâtel, Switzerland) & Vincent Chappuis. (HE-Arc CR, Neuchâtel, Neuchâtel, Switzerland)
Url	/artefacts/907/

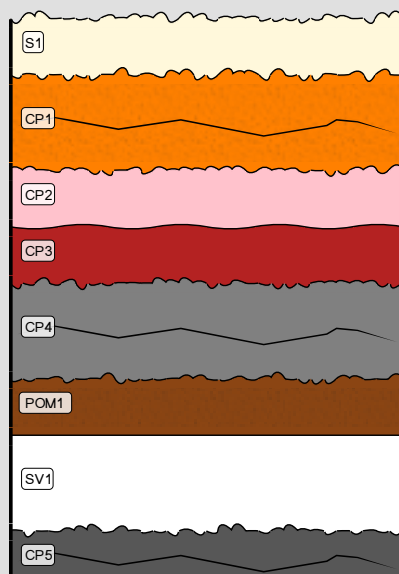
Fig. 12: Stratigraphic representation of the nail in cross-section (dark field) using the MiCorr application. The characteristics of the strata are only accessible by clicking on the drawing that redirects you to the search tool by stratigraphy representation. This representation can be compared to Fig. 14, Credit HE-Arc CR, V.Chappuis.

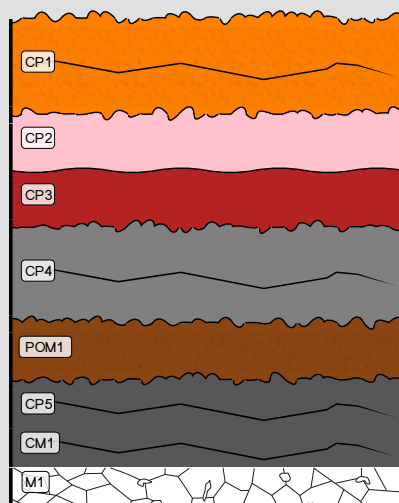
Fig. 13: Stratigraphic representation of the nail in cross-section (dark field) using the MiCorr application. The characteristics of the strata are only accessible by clicking on the drawing that redirects you to the search tool by stratigraphy representation. This representation can be compared to Fig. 14, Credit HE-Arc CR, V.Chappuis.
