# SHOE NAIL 2637 1370.B. – HYPOEUTECTOID STEEL – ROMAN TIMES – SWITZERLAND

Artefact name	Shoe nail 2637 1370.B.
Authors	Christian. Degriigny (HE-Arc CR, Neuchâtel, Neuchâtel, Switzerland) & Valentin. Boissonnas (HE-Arc CR, Neuchâtel, Neuchâtel, Switzerland) & Vincent Chappuis. (HE-Arc CR, Neuchâtel, Neuchâtel, Switzerland)
Url	/artefacts/907/

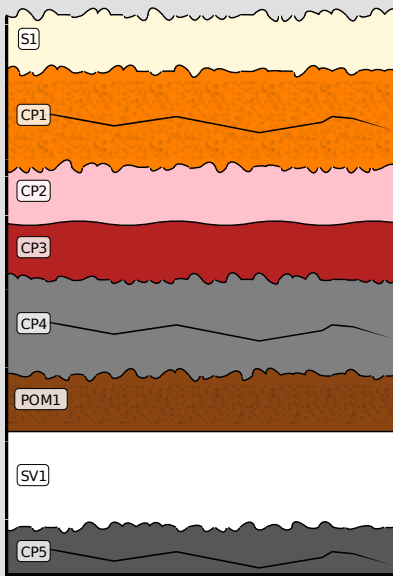
Fig. 12: Stratigraphic representation of the nail in cross-section (dark field) using the MiCorr application. The characteristics of the strata are only accessible by clicking on the drawing that redirects you to the search tool by stratigraphy representation. This representation can be compared to Fig. 14, Credit HE-Arc CR, V.Chappuis.

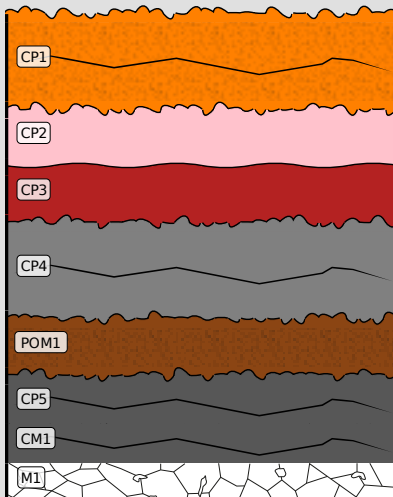
Fig. 13: Stratigraphic representation of the nail in cross-section (dark field) using the MiCorr application. The characteristics of the strata are only accessible by clicking on the drawing that redirects you to the search tool by stratigraphy representation. This representation can be compared to Fig. 14, Credit HE-Arc CR, V.Chappuis.

CP1 = powdery orange (loosely coherent) and matte corrosion crust, sometimes forming humps. Partially mixed with S1 and POM layers (diffused interfaces). 1 to 5 millimeters thick.

CP2 = vivid red or pink dots, more brittle than powdery (loose cohesion) and mostly matte, only two or three observed, always above CP3 interfaces. Usually 1 mm spheric diameter.

CP3 = dark reddish corrosion product, forming smooth, matte and brittle layers that are parallel to CP4, with a clean and regular interface. The corrosion products are generally hard, but sometimes break up into grains, resulting in a more irregular interface. The layer is approximately 0.5mm thick.

CP4 = dark grey to black corrosion product, smooth with pseudo-metallic reflection (a bit glossy), very hard, when scratched results in orange powder, with somewhat irregular shape and thickness (ranging from 0.3 to 2mm).

CP5 = dark grey to black corrosion product, generally a bit darker than CP4. Smooth with pseudo-metallic reflection, even harder than CP4 and when scratched it turns into an orange coloured powder. Irregular interface regarding CP4. Clear transition and somewhat parallel from CP4 to CP5. As regards its thickness, it fills the remaining volume.

SV = structural void, present as fissures that either pass through the different layers, or are present at corrosion interfaces, especially at the CP4/CP5 interface. The void is 0.1 to 0.3mm thick and partially filled with POM in the outer layers.
