# SHOE NAIL 2637 1370.B. - HYPOEUTECTOID STEEL - ROMAN TIMES - SWITZERLAND

**Artefact name** Shoe nail 2637 1370.B.

**Authors** Christian. Degrigny (HE-Arc CR, Neuchâtel, Neuchâtel, Switzerland) & Valentin. Boissonnas (HE-Arc CR, Neuchâtel, Neuchâtel, Switzerland) & Vincent Chappuis. (HE-Arc CR, Neuchâtel, Neuchâtel, Switzerland)

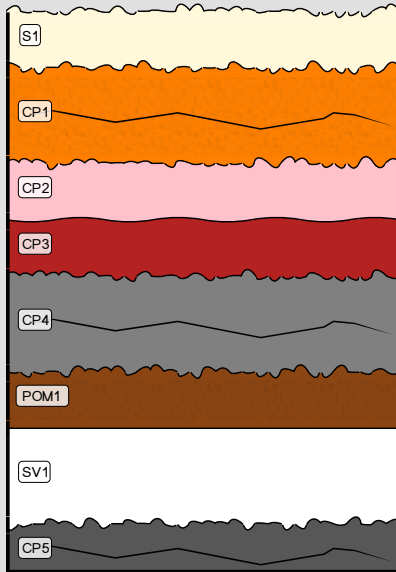
Fig. 12: Stratigraphic representation of the nail in cross-section (dark field) using the MiCorr application. The characteristics of the strata are only accessible by clicking on the drawing that redirects you to the search tool by stratigraphy representation. This representation can be compared to Fig. 14, Credit HE-Arc CR, V.Chappuis.

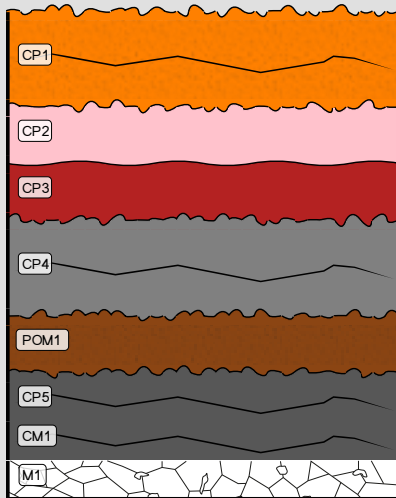
Fig. 13: Stratigraphic representation of the nail in cross-section (dark field) using the MiCorr application. The characteristics of the strata are only accessible by clicking on the drawing that redirects you to the search tool by stratigraphy representation. This representation can be compared to Fig. 14, Credit HE-Arc CR, V.Chappuis.
