# COFFEE FILTER – AL ALLOY – MODERN TIMES – FRANCE

**Artefact name** Coffee filter

**Authors** Christian. Degriigny (HE-Arc CR, Neuchâtel, Neuchâtel, Switzerland)

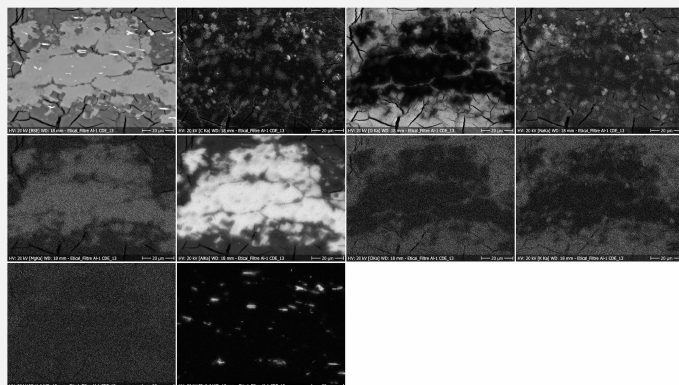
The average thickness of the corrosion layer (CP1) is about 50 micrometers, but may be thinner or thicker depending on the area. Intergranular corrosion developed locally to extend through the entire thickness of the metal. EDS-SEM analysis indicates that the metal is, as expected, covered by a layer rich in Al and O containing chlorides (red spots on Fig. 8) and surprisingly Na (white rectangle on Fig. 8, Figs. 9 and 10). Chlorides do not seem to form active corrosion. A new examination carried out after 4 months (Fig. 11) shows new forms of alteration with a local enrichment of Na, C and O (Na<sub>2</sub>CO<sub>3</sub>?).

Fig. 8: SEM picture (detail of Fig. 4 with location (red spots) of EDS analyses of Fig. 9), BSE-mode. From bottom to top left: the metal (M1) in light grey, the corroded metal (CM1) and CP1. The area selected for elemental chemical distributions (Figs. 10 and 11) is marked by a rectangle,
