COFFEE FILTER – AL ALLOY – MODERN TIMES – FRANCE

Artefact name	Coffee filter
Authors	Christian. Degriigny (HE-Arc CR, Neuchâtel, Neuchâtel, Switzerland)
Url	/artefacts/911/

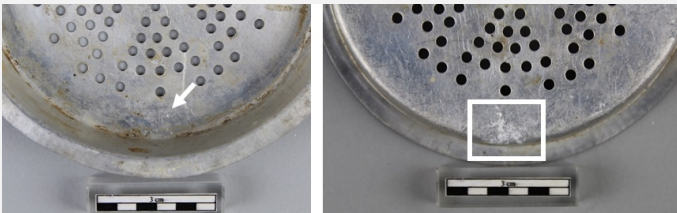
Fig. 2: Detail of the front (left) and back (right) sides of the coffee filter showing the location of Fig. 3,

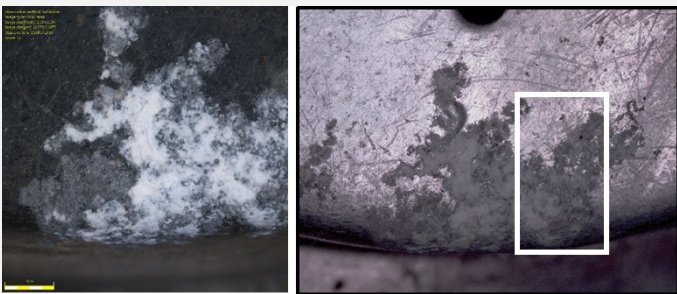
Fig. 3: Detail of the back side of the coffee filter showing the location of the sampling area (white rectangle),

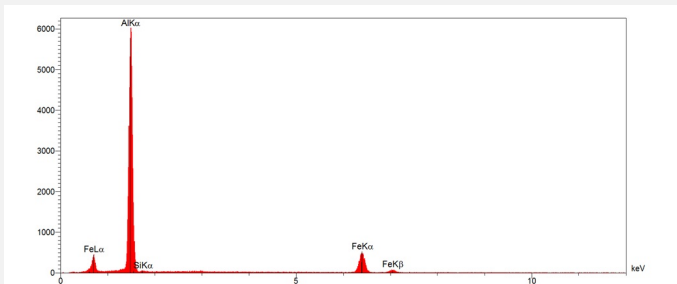
The metal is a relatively pure aluminium alloy with numerous elongated inclusions (Fig. 5). From their chemical composition they can be interpreted as Al₃Fe intermetallic compounds (Fig. 6). Inter- and transgranular corrosion has developed so extensively that some grains (not elongated) are outlined (Fig. 7).

Fig. 6: EDS spectrum of the elongated white inclusions of Fig. 5,

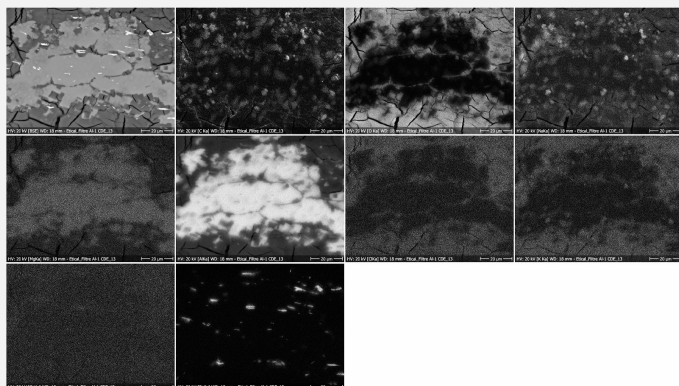
The average thickness of the corrosion layer (CP1) is about 50 micrometers, but may be thinner or thicker depending on the area. Intergranular corrosion developed locally to extend through the entire thickness of the metal. EDS-SEM analysis indicates that the metal is, as expected, covered by a layer rich in Al and O containing chlorides (red spots on Fig. 8) and surprisingly Na (white rectangle on Fig. 8, Figs. 9 and 10). Chlorides do not seem to form active corrosion. A new examination carried out after 4 months (Fig. 11) shows new forms of alteration with a local enrichment of Na, C and O (Na₂CO₃?).

Fig. 10: SEM image, BSE-mode, and elemental chemical distribution of the selected area of Fig. 8. Method of examination: SEM-EDS, Lab of Electronic Microscopy and Microanalysis, IMA (Néode), HEI Arc,
