# COFFEE FILTER – AL ALLOY – MODERN TIMES – FRANCE

**Artefact name** Coffee filter

**Authors** Christian. Degrigny (HE-Arc CR, Neuchâtel, Neuchâtel, Switzerland)

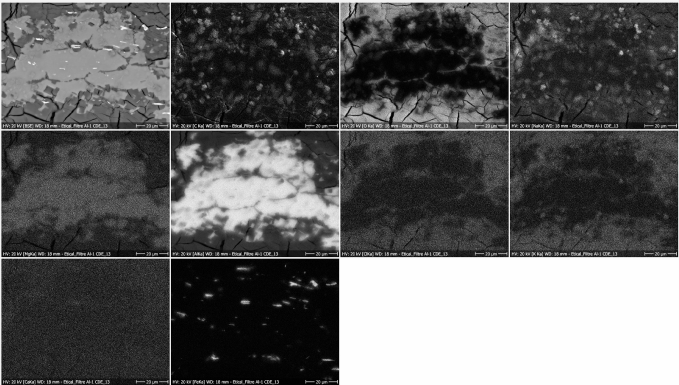
The average thickness of the corrosion layer (CP1) is about 50 micrometers, but may be thinner or thicker depending on the area. Intergranular corrosion developed locally to extend through the entire thickness of the metal. EDS-SEM analysis indicates that the metal is, as expected, covered by a layer rich in Al and O containing chlorides (red spots on Fig. 8) and surprisingly Na (white rectangle on Fig. 8, Figs. 9 and 10). Chlorides do not seem to form active corrosion. A new examination carried out after 4 months (Fig. 11) shows new forms of alteration with a local enrichment of Na, C and O (Na2CO3?).

Fig. 8: SEM picture (detail of Fig. 4 with location (red spots) of EDS analyses of Fig. 9), BSE-mode. From bottom to top left: the metal (M1) in light grey, the corroded metal (CM1) and CP1. The area selected for elemental chemical distributions (Figs. 10 and 11) is marked by a rectangle,
