CIRCULAR DOOR KNOCKER STRIKING PLATE – CU ALLOY – MODERN TIMES – SWITZERLAND

Artefact name	Circular door knocker striking plate
Authors	Marianne. Senn (Empa, Dübendorf, Zurich, Switzerland) & Christian. Degryny (HE-Arc CR, Neuchâtel, Neuchâtel, Switzerland)
Url	/artefacts/919/

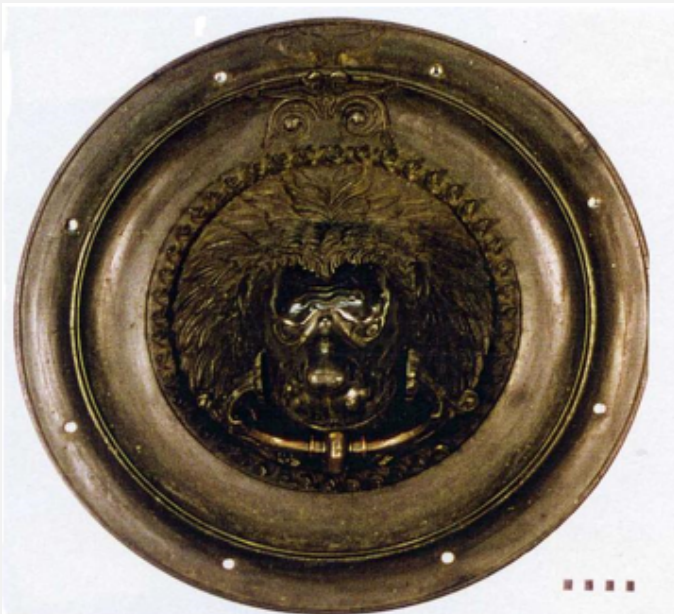
Fig. 1: Circular door knocker striking plate (after Benoît, 1994),

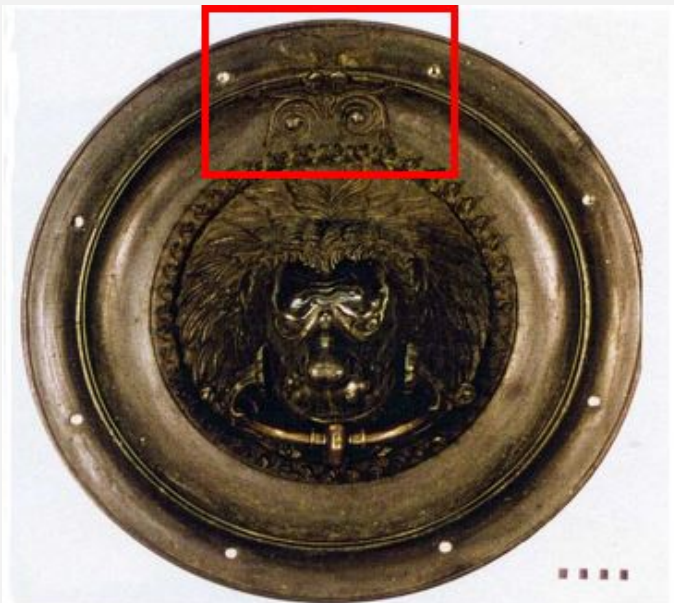
Fig. 2: Possible location of sampling area,

Description of sample	No information is given on where the sample has been taken. A supposed location is however illustrated in Fig. 2. The polished sample shows a well preserved metal surface with some cracks covered by a thin corrosion crust (Fig. 3).
Alloy	Cu Alloy
Technology	Rolled, annealed after cold working
Lab number of sample	MAH 94-156-001
Sample location	Musées d'art et d'histoire, Genève, Geneva
Responsible institution	Musées d'art et d'histoire, Genève, Geneva
Date and aim of sampling	1994, metallography and presence or not of a gilding treatment
