LEAD CAMES OF A STAINED GLASS WINDOW 52583 – PB SB ALLOY – UNKNOWN – SWITZERLAND

Artefact name Lead comes of a stained glass window 52583

Authors Alice Gerber. (Haute École Arc Neuchâtel, Neuchâtel, Neuchâtel, Switzerland)

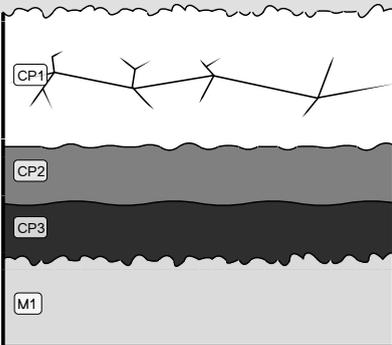
Fig. 4: Stratigraphic representation of the lead came under binocular using the MiCorr application. The characteristics of the strata are only accessible by clicking on the drawing that redirects you to the search tool by stratigraphy representation, Credit HE-Arc CR, A.Gerber.

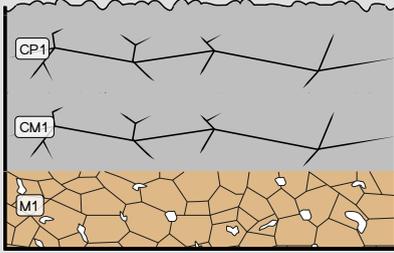
Corrosion develops specifically on comes made of a lead-antimony alloy, where antimony inclusions constitute the cathode (0.150 V/SHE) versus lead (-0.125 V/SHE) which corrodes as an anode in presence of lead acetate (the electrolyte). Fig. 8 shows that corrosion does not attack the antimony nodules in the alloy, it progresses by mineralizing the lead around these nodules.

CP1 seems to be a heterogeneous compound as indicated on Figs. 8 and 9. It is heavily cracked (Fig. 9). EDX analyses do not indicate a significant difference in composition. The attack of lead by organic acids causes the formation of salts, such as lead acetate which are then transformed into basic lead carbonates by the action of CO₂ from the environment as indicated by FTIR analysis of CP1.

Fig. 10: Stratigraphic representation of the lead came in cross-section (dark field) using the MiCorr application with reference to Fig. 8. The characteristics of the strata are only accessible by clicking on the drawing that redirects you to the search tool by stratigraphy representation, Credit HE-Arc CR, A.Gerber
