LEAD CAMES OF A STAINED GLASS WINDOW 52583 - PB SB ALLOY - UNKNOWN - SWITZERLAND

Artefact name Lead cames of a stained glass window 52583

Authors Alice Gerber. (Haute École Arc Neuchâtel, Neuchâtel, Neuchâtel, Switzerland)

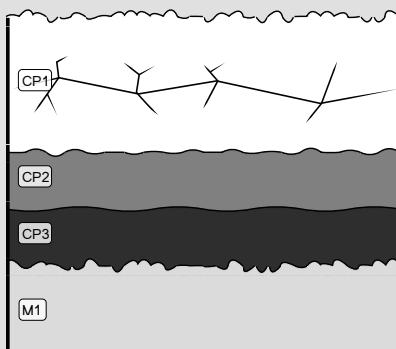
Fig. 4: Stratigraphic representation of the lead came under binocular using the MiCorr application. The characteristics of the strata are only accessible by clicking on the drawing that redirects you to the search tool by stratigraphy representation, Credit HE-Arc CR, A.Gerber.

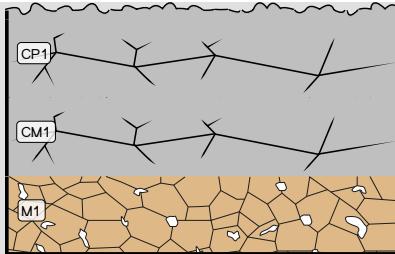
Corrosion develops specifically on cames made of a lead-antimony alloy, where antimony inclusions constitute the cathode (0.150 V/SHE) versus lead (-0.125 V/SHE) which corrodes as an anode in presence of lead acetate (the electrolyte). Fig. 8 shows that corrosion does not attack the antimony nodules in the alloy, it progresses by mineralizing the lead around these nodules.

CP1 seems to be an heterogeneous compound as indicated on Figs. 8 and 9. It is heavily cracked (Fig. 9). EDX analyses do not indicate a significant difference in composition. The attack of lead by organic acids causes the formation of salts, such as lead acetate which are then transformed into basic lead carbonates by the action of CO₂ from the environment as indicated by FTIR analysis of CP1.

Fig. 10: Stratigraphic representation of the lead came in cross-section (dark field) using the MiCorr application with reference to Fig. 8. The characteristics of the strata are only accessible by clicking on the drawing that redirects you to the search tool by stratigraphy representation, Credit HE-Arc CR, A.Gerber
