# LEAD CAMES OF A STAINED GLASS WINDOW 52583 – PB SB ALLOY – UNKNOWN – SWITZERLAND

**Artefact name** Lead comes of a stained glass window 52583

**Authors** Alice Gerber. (Haute École Arc Neuchâtel, Neuchâtel, Neuchâtel, Switzerland)

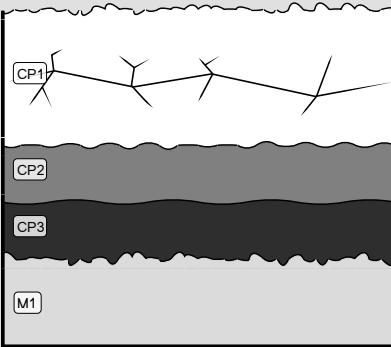
Fig. 4: Stratigraphic representation of the lead came under binocular using the MiCorr application. The characteristics of the strata are only accessible by clicking on the drawing that redirects you to the search tool by stratigraphy representation, Credit HE-Arc CR, A.Gerber.

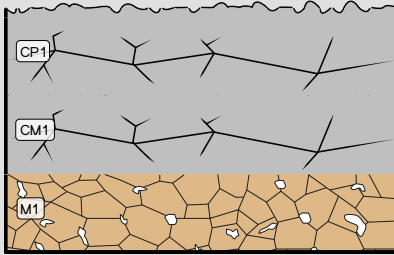
Corrosion develops specifically on comes made of a lead-antimony alloy, where antimony inclusions constitute the cathode (0.150 V/SHE) versus lead (-0.125 V/SHE) which corrodes as an anode in presence of lead acetate (the electrolyte). Fig. 8 shows that corrosion does not attack the antimony nodules in the alloy, it progresses by mineralizing the lead around these nodules.

<b>Corrosion form</b>	Uniform - transgranular
<b>Corrosion type</b>	Active corrosion of lead

Fig. 10: Stratigraphic representation of the lead came in cross-section (dark field) using the MiCorr application with reference to Fig. 8. The characteristics of the strata are only accessible by clicking on the drawing that redirects you to the search tool by stratigraphy representation, Credit HE-Arc CR, A.Gerber
