LEAD CAMES OF A STAINED GLASS WINDOW 52583 – PB SB ALLOY – UNKNOWN – SWITZERLAND

Artefact name Lead comes of a stained glass window 52583

Authors Alice Gerber. (Haute École Arc Neuchâtel, Neuchâtel, Neuchâtel, Switzerland)

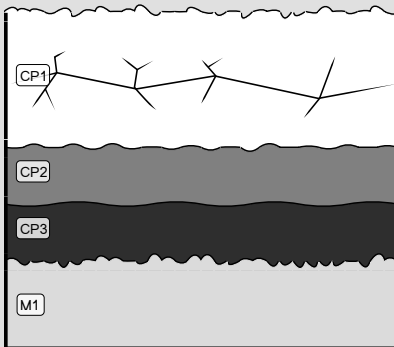
Fig. 4: Stratigraphic representation of the lead came under binocular using the MiCorr application. The characteristics of the strata are only accessible by clicking on the drawing that redirects you to the search tool by stratigraphy representation, Credit HE-Arc CR, A.Gerber.

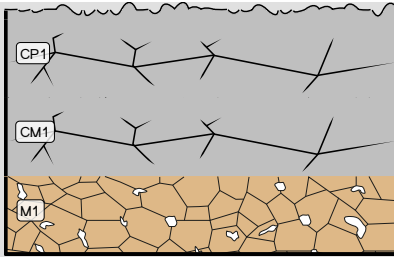
Corrosion develops specifically on comes made of a lead-antimony alloy, where antimony inclusions constitute the cathode (0.150 V/SHE) versus lead (-0.125 V/SHE) which corrodes as an anode in presence of lead acetate (the electrolyte). Fig. 8 shows that corrosion does not attack the antimony nodules in the alloy, it progresses by mineralizing the lead around these nodules.

Fig. 10: Stratigraphic representation of the lead came in cross-section (dark field) using the MiCorr application with reference to Fig. 8. The characteristics of the strata are only accessible by clicking on the drawing that redirects you to the search tool by stratigraphy representation, Credit HE-Arc CR, A.Gerber
