LEAD CAMES OF A STAINED GLASS WINDOW 52583 – PB SB ALLOY – UNKNOWN – SWITZERLAND

Artefact name	Lead comes of a stained glass window 52583
Authors	Alice Gerber. (Haute École Arc Neuchâtel, Neuchâtel, Neuchâtel, Switzerland)
Url	/artefacts/924/

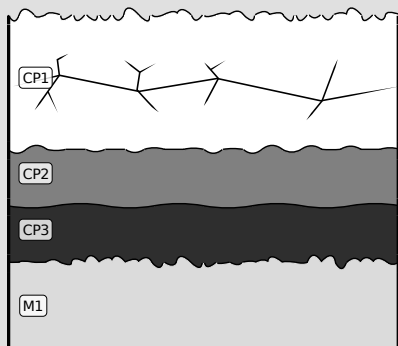
Fig. 4: Stratigraphic representation of the lead came under binocular using the MiCorr application. The characteristics of the strata are only accessible by clicking on the drawing that redirects you to the search tool by stratigraphy representation, Credit HE-Arc CR, A.Gerber.

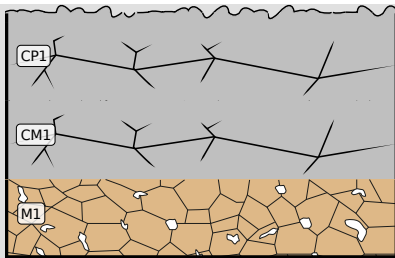
Corrosion develops specifically on comes made of a lead-antimony alloy, where antimony inclusions constitute the cathode (0.150 V/SHE) versus lead (-0.125 V/SHE) which corrodes as an anode in presence of lead acetate (the electrolyte). Fig. 8 shows that corrosion does not attack the antimony nodules in the alloy, it progresses by mineralizing the lead around these nodules.

Fig. 10: Stratigraphic representation of the lead came in cross-section (dark field) using the MiCorr application with

reference to Fig. 8. The characteristics of the strata are only accessible by clicking on the drawing that redirects you to the search tool by stratigraphy representation, Credit HE-Arc CR, A.Gerber
