LEAD CAMES OF A STAINED GLASS WINDOW 52583 – PB SB ALLOY – UNKNOWN – SWITZERLAND

Artefact name Lead comes of a stained glass window 52583

Authors Alice Gerber. (Haute École Arc Neuchâtel, Neuchâtel, Neuchâtel, Switzerland)

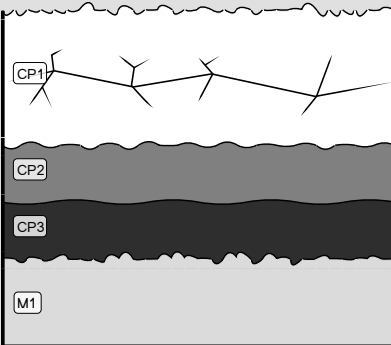
Fig. 4: Stratigraphic representation of the lead came under binocular using the MiCorr application. The characteristics of the strata are only accessible by clicking on the drawing that redirects you to the search tool by stratigraphy representation, Credit HE-Arc CR, A.Gerber.

Corrosion develops specifically on comes made of a lead-antimony alloy, where antimony inclusions constitute the cathode (0.150 V/SHE) versus lead (-0.125 V/SHE) which corrodes as an anode in presence of lead acetate (the electrolyte). Fig. 8 shows that corrosion does not attack the antimony nodules in the alloy, it progresses by mineralizing the lead around these nodules.

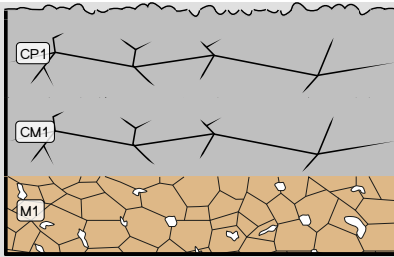
CP1 seems to be a heterogeneous compound as indicated on Figs. 8 and 9. It is heavily cracked (Fig. 9). EDX analyses do not indicate a significant difference in composition. The attack of lead by organic acids causes the formation of salts, such as lead acetate which are then transformed into basic lead carbonates by the action of CO₂ from the environment as indicated by FTIR analysis of CP1.

Fig. 10: Stratigraphic representation of the lead came in cross-section (dark field) using the MiCorr application with reference to Fig. 8. The characteristics of the strata are only accessible by clicking on the drawing that redirects you to the search tool by stratigraphy representation, Credit HE-Arc CR, A.Gerber
