CORRODED METAL SHEET FN 655.13.01 – FE ALLOY – MODERN TIMES – SWITZERLAND

Artefact name Corroded metal sheet FN 655.13.01

Authors Marianne. Senn (Empa, Dübendorf, Zurich, Switzerland) & Christian. Degryny (HE-Arc CR, Neuchâtel, Neuchâtel, Switzerland)

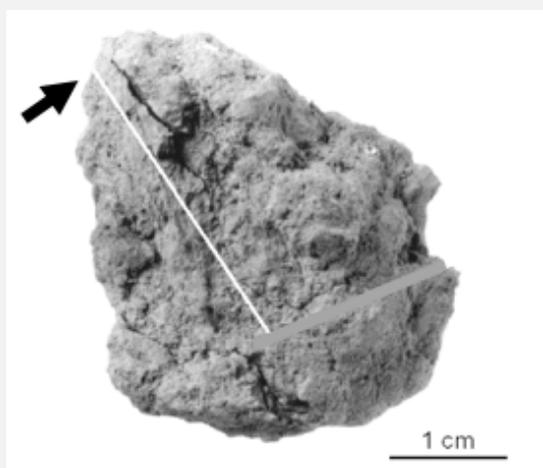
Fig. 2: Location of sampling area,

Description of sample	A longitudinal cut has been made through the sheet (Fig. 2). Large parts of the corrosion crust fell off during sampling (Fig. 3).
Alloy	Fe Alloy
Technology	Forged with final cold work
Lab number of sample	NEF 655
Sample location	HE-Arc CR, Neuchâtel, Neuchâtel
Responsible institution	Kantonsarchäologie, Dübendorf, Zurich
Date and aim of sampling	2000, metallography
