# SHOE NAIL 2637 1370.B. – HYPOEUTECTOID STEEL – ROMAN TIMES – SWITZERLAND

Artefact name	Shoe nail 2637 1370.B.
Authors	Christian. Degriigny (HE-Arc CR, Neuchâtel, Neuchâtel, Switzerland) & Valentin. Boissonnas (HE-Arc CR, Neuchâtel, Neuchâtel, Switzerland) & Vincent Chappuis. (HE-Arc CR, Neuchâtel, Neuchâtel, Switzerland)
Url	/artefacts/973/

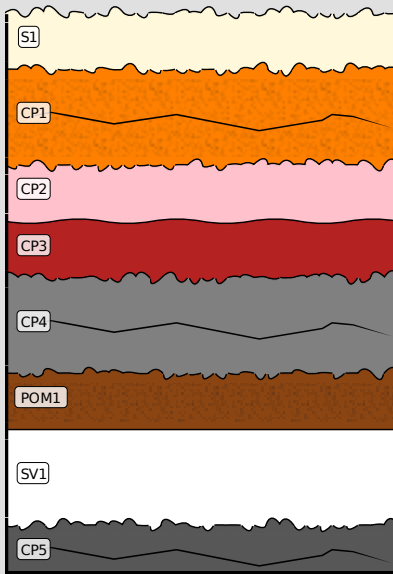
Fig. 12: Stratigraphic representation of the nail in cross-section (dark field) using the MiCorr application. The characteristics of the strata are only accessible by clicking on the drawing that redirects you to the search tool by stratigraphy representation. This representation can be compared to Fig. 14, Credit HE-Arc CR, V.Chappuis.

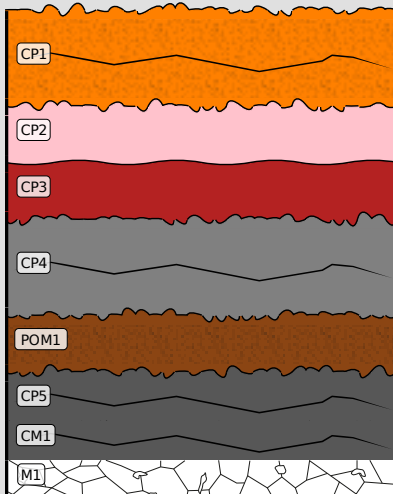
stratigraphic layers based on SEM-EDS elemental mapping (Fig. 13). Y = yes; N = no; NA = not applicable (not observed). + = more compared to other layers; - = less compared to other layers. \*Probably pushed back by coating resin. \*\*Though SEM-EDS analysis showed that the metal is an iron-carbon alloy with inclusions of Si, Al, P and K.

Fig. 13: Stratigraphic representation of the nail in cross-section (dark field) using the MiCorr application. The characteristics of the strata are only accessible by clicking on the drawing that redirects you to the search tool by stratigraphy representation. This representation can be compared to Fig. 14, Credit HE-Arc CR, V.Chappuis.
