SHOE NAIL 2637 1370.B. - HYPOEUTECTOID STEEL - ROMAN TIMES - SWITZERLAND

Artefact name Shoe nail 2637 1370.B.

Authors Christian. Degrigny (HE-Arc CR, Neuchâtel, Neuchâtel, Switzerland) & Valentin. Boissonnas (HE-Arc CR, Neuchâtel, Neuchâtel, Switzerland) & Vincent Chappuis. (HE-Arc CR, Neuchâtel, Neuchâtel, Switzerland)

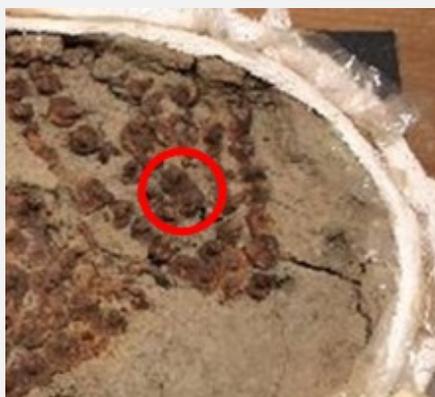
Fig. 2: Incomplete shoe from which the nail was sampled (in red circle),

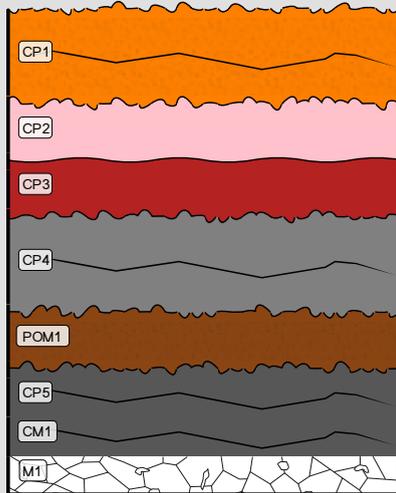
Fig. 12: Stratigraphic representation of the nail in cross-section (dark field) using the MiCorr application. The characteristics of the strata are only accessible by clicking on the drawing that redirects you to the search tool by stratigraphy representation. This representation can be compared to Fig. 14, Credit HE-Arc CR, V.Chappuis.

Fig. 13: Stratigraphic representation of the nail in cross-section (dark field) using the MiCorr application. The characteristics of the strata are only accessible by clicking on the drawing that redirects you to the search tool by stratigraphy representation. This representation can be compared to Fig. 14, Credit HE-Arc CR, V.Chappuis.
