FRAGMENT OF AN AEGIS OF NEÏTH 1886.305.0096 – LEADED BRONZE

Artefact name Fragment of an Aegis of Neïth 1886.305.0096

Authors Line. Pedersen (HE-Arc, Neuchâtel, Neuchâtel, Switzerland) & Christian. Degrigny (HE-Arc CR, Neuchâtel, Neuchâtel, Switzerland) & Valentin. Boissonnas (HE-Arc CR, Neuchâtel, Neuchâtel, Switzerland)

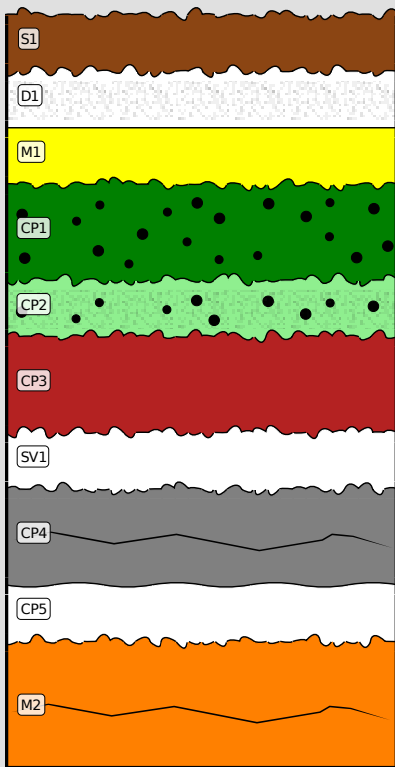
Fig.9: Schematic representation combining stratigraphies 1 and 2 under binocular microscope and using the MiCorr application. The characteristics of the strata are only accessible by clicking on the drawing that redirects you to the search tool by stratigraphy representation, Credit He-Arc CR, L.Pedersen.

The metal (M2 in Fig.9 and M1 in Fig. 10) was analysed on the broken edge of the bottom of the artefact where despite a highly corroded surface, the metal seems to be the best preserved. The XRF analyses revealed that the metal is a leaded bronze with remains of gold leaf on the surface (Table 1, Au was detected in the measurement spots 4,5 and 6) (Scott 2002; Gouda 2012; Mohammed 2012).

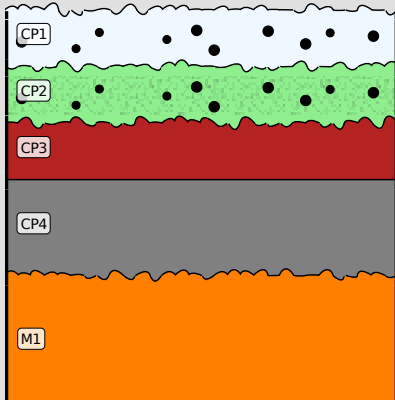
Fig.10: Schematic representation of stratigraphy 3 under binocular microscope and using the MiCorr application. CP1 is CP6 in Fig. 8. The characteristics of the strata are only accessible by clicking on the drawing that redirects you to the search tool by stratigraphy representation, Credit He-Arc CR, L. Pedersen.
