FRAGMENT OF AN AEGIS OF NEÏTH 1886.305.0096 – LEADED BRONZE

Artefact name Fragment of an Aegis of Neïth 1886.305.0096

Authors Line. Pedersen (HE-Arc, Neuchâtel, Neuchâtel, Switzerland) & Christian. Degriigny (HE-Arc CR, Neuchâtel, Neuchâtel, Switzerland) & Valentin. Boissonnas (HE-Arc CR, Neuchâtel, Neuchâtel, Switzerland)

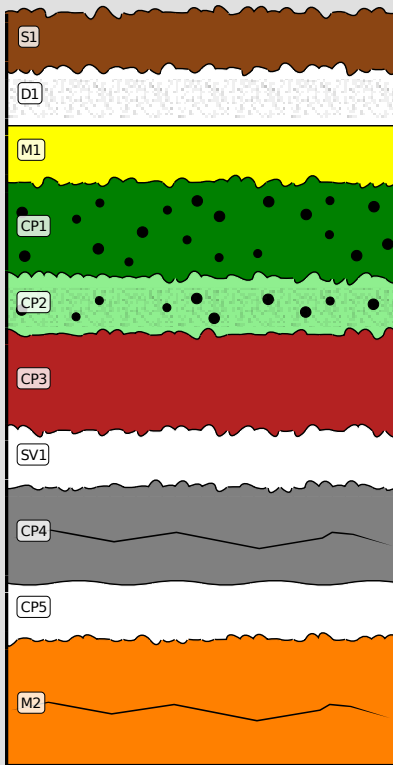
Fig.9: Schematic representation combining stratigraphies 1 and 2 under binocular microscope and using the MiCorr application. The characteristics of the strata are only accessible by clicking on the drawing that redirects you to the search tool by stratigraphy representation, Credit He-Arc CR, L.Pedersen.

The metal (M2 in Fig.9 and M1 in Fig. 10) was analysed on the broken edge of the bottom of the artefact where despite a highly corroded surface, the metal seems to be the best preserved. The XRF analyses revealed that the metal is a leaded bronze with remains of gold leaf on the surface (Table 1, Au was detected in the measurement spots 4,5 and 6) (Scott 2002; Gouda 2012; Mohammed 2012).

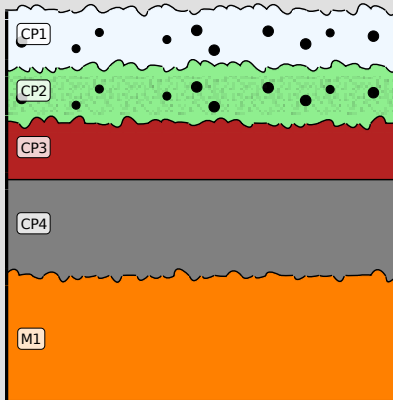
Fig.10: Schematic representation of stratigraphy 3 under binocular microscope and using the MiCorr application. CP1 is CP6 in Fig. 8. The characteristics of the strata are only accessible by clicking on the drawing that redirects you to the search tool by stratigraphy representation, Credit He-Arc CR, L. Pedersen.
