LEAD CAMES OF A STAINED GLASS WINDOW 52583 – PB SB ALLOY – UNKNOWN – SWITZERLAND

Artefact name Lead comes of a stained glass window 52583

Authors Alice Gerber. (Haute École Arc Neuchâtel, Neuchâtel, Neuchâtel, Switzerland)

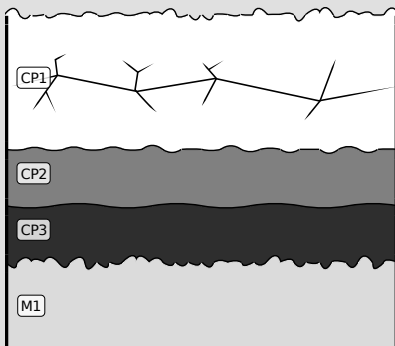
Fig. 4: Stratigraphic representation of the corrosion structure of the lead came observed macroscopically under binocular microscope using the MiCorr application. The characteristics of the strata are only accessible by clicking on the drawing that redirects you to the search tool by stratigraphy representation, Credit HE-Arc CR, A.Gerber.

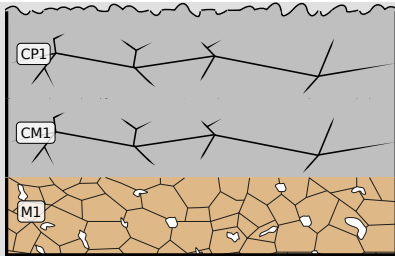
CP1 seems to be a heterogeneous compound as indicated on Figs. 8 and 9. It is heavily cracked (Fig. 9). EDX analyses do not indicate a significant difference in composition. The attack of lead by organic acids causes the formation of salts, such as lead acetate which are then transformed into basic lead carbonates by the action of CO₂ from the environment as indicated by FTIR analysis of CP1.

Fig. 10: Stratigraphic representation of the lead came in cross-section (dark field) using the MiCorr application with

reference to Fig. 8. The characteristics of the strata are only accessible by clicking on the drawing that redirects you to the search tool by stratigraphy representation, Credit HE-Arc CR, A.Gerber
