LEAD CAMES OF A STAINED GLASS WINDOW 52583 – PB SB ALLOY – UNKNOWN – SWITZERLAND

Artefact name Lead comes of a stained glass window 52583

Authors Alice Gerber. (Haute École Arc Neuchâtel, Neuchâtel, Neuchâtel, Switzerland)

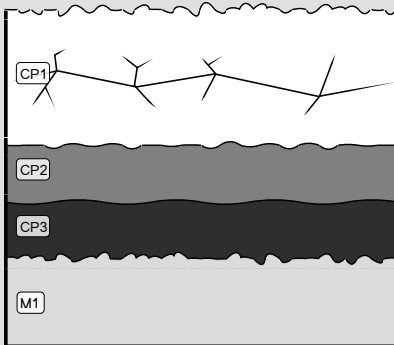
Fig. 4: Stratigraphic representation of the corrosion structure of the lead came observed macroscopically under binocular microscope using the MiCorr application. The characteristics of the strata are only accessible by clicking on the drawing that redirects you to the search tool by stratigraphy representation, Credit HE-Arc CR, A.Gerber.

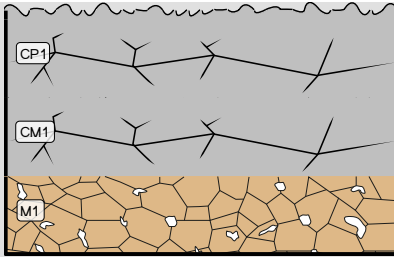
Corrosion develops specifically on comes made of a lead-antimony alloy, where antimony inclusions constitute the cathode (0.150 V/SHE) versus lead (-0.125 V/SHE) which corrodes as an anode in presence of lead acetate (the electrolyte). Fig. 8 shows that corrosion does not attack the antimony nodules in the alloy, it progresses by mineralizing the lead around these nodules.

Fig. 10: Stratigraphic representation of the lead came in cross-section (dark field) using the MiCorr application with reference to Fig. 8. The characteristics of the strata are only accessible by clicking on the drawing that redirects you to the search tool by stratigraphy representation, Credit HE-Arc CR, A.Gerber
