FUNERAL MASK IVC 11595 - CU/AG, WITH SURFACE ENRICHMENT (AG) - UNKNOWN

Artefact name Funeral mask Ivc 11595

Authors Christian. Degriigny (HE-Arc CR, Neuchâtel, Neuchâtel, Switzerland) & Naima. Gutknecht (HE-Arc CR, Neuchâtel, Neuchâtel, Switzerland) & Valentin. Boissonnas (HE-Arc CR, Neuchâtel, Neuchâtel, Switzerland)

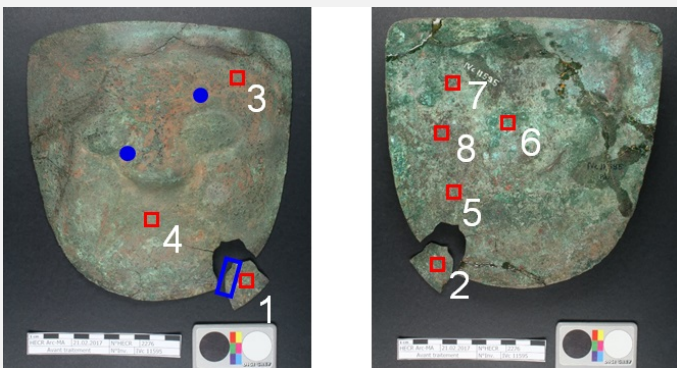
Fig. 2: Front (left) and back (right) faces showing the location of XRF analyses (red squares), sampling areas for SEM-EDS (blue points) and sampling area for examination on cross-section (blue rectangle),

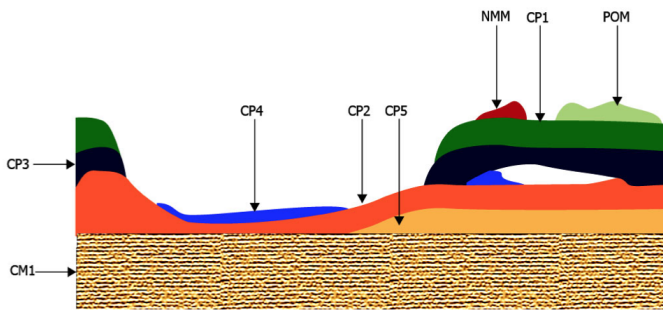
Fig. 3b: Stratigraphic representation of the back face of the funeral mask by visual macroscopic observation,

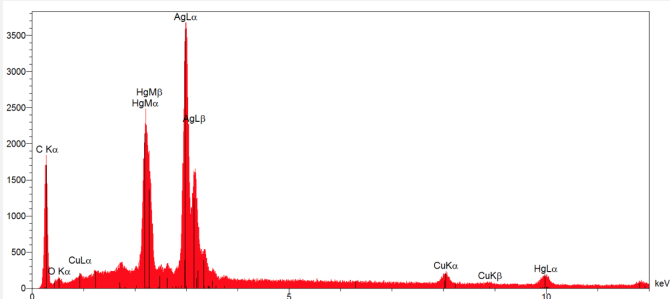
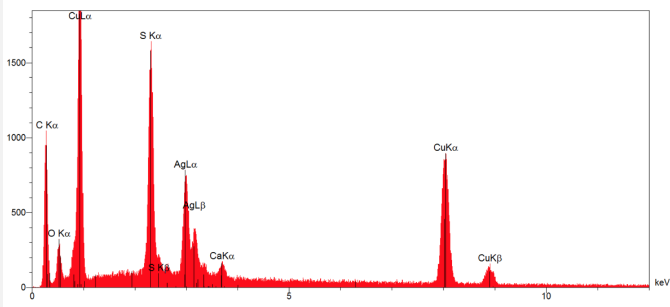
Figs. 10: EDS analysis of the layer that appears light grey under polarized light, situated below the red layer (Fig. 4). Method of analysis: SEM-EDS, Lab of Electronic Microscopy and Microanalysis, IMA (Néode), HEI Arc,

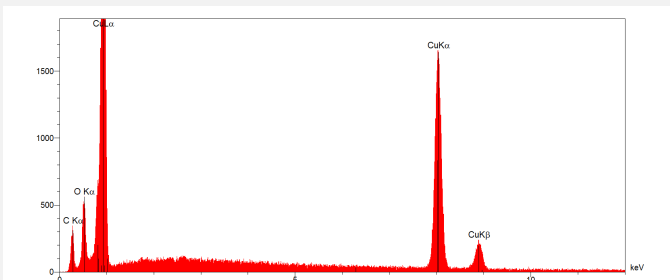
The silver enriched surface is entirely covered with copper corrosion products. The outer green layer (CP1) is a copper carbonate (Fig. 11, Table 1), while the red layers (CP2 in Fig. 15 ; CP4 and CP5 in Fig. 16) are consisting of a copper oxide, most likely cuprite (Fig. 9). Below the cuprite and above the silver enriched surface on the front face a thin black layer is present (appears grey under polarized light). SEM-EDS analysis shows that in that stratum the mercury of the pigment (Fig. 14) has been transformed into a mercury-silver compound (Figs. 7 and 10) which according to Raman spectrometry (Fig. 14) is not cinnabar anymore. In areas this silver- and mercury-rich surface has been pulled off by raising the corrosion layers, leaving structural voids that were subsequently filled by secondary corrosion products, most likely copper carbonates (Figs. 6 and 7).

Fig. 11: EDS analysis of the green corrosion layer that has filled the structural void (Fig. 4). Method of analysis: SEM-EDS, Lab of Electronic Microscopy and Microanalysis, IMA (Néode), HEI Arc,

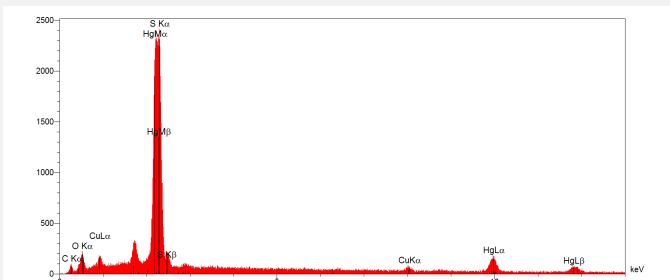
Fig. 12: EDS analysis of the red surface pigment from a surface sample. Method of analysis: SEM-EDS, Lab of Electronic Microscopy and Microanalysis, IMA (Néode), HEI Arc,

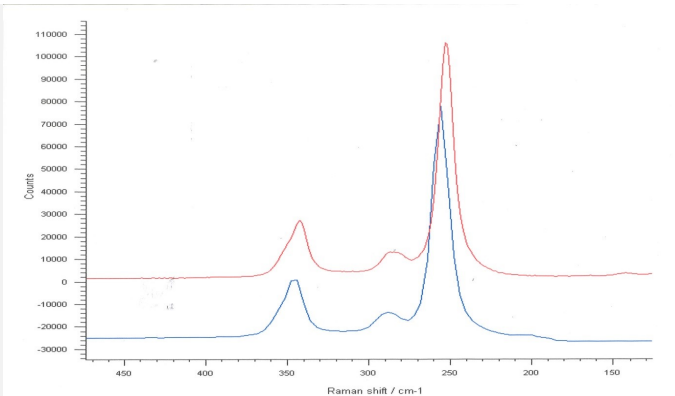
The silver sulphide (HgS, cinnabar, Fig. 13), present as a red pigment on the silver surface, could have been reduced through an electrochemical process in the presence of chlorides (Keune 2005). The released sulfur recombined with the silver to form black silver sulphide. Above that layer a porous mercury- and silver rich stratum has formed (see Hg & Ag on cartography Fig. 8). It remains unclear if the limitos is located in the silver enriched surface or within this silver-mercury compound (Fig. 7).

Fig. 13: Raman analysis of the red pigment on the surface (red line) and the references for cinnabar (blue line). Method of analysis: Raman spectroscopy, HKB,
