# FUNERAL MASK IVC 11595 – CU/AG, WITH SURFACE ENRICHMENT (AG) – UNKNOWN

**Artefact name** Funeral mask IVC 11595

**Authors** Christian. Degriigny (HE-Arc CR, Neuchâtel, Neuchâtel, Switzerland) & Naima. Gutknecht (HE-Arc CR, Neuchâtel, Neuchâtel, Switzerland) & Valentin. Boissonnas (HE-Arc CR, Neuchâtel, Neuchâtel, Switzerland)

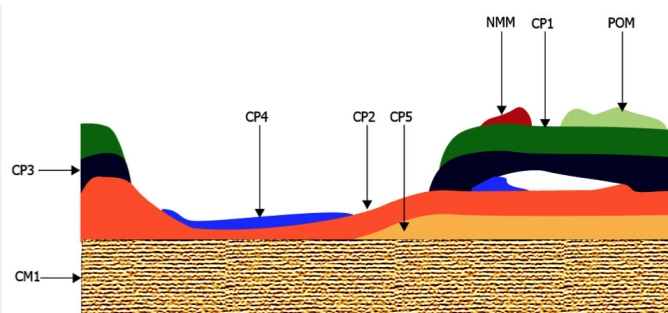
Fig. 3a: Stratigraphic representation of the front face of the funeral mask by visual macroscopic observation,

Fig. 3b: Stratigraphic representation of the back face of the funeral mask by visual macroscopic observation,

**POM:** Textile remains, **NMM:** Pigments, **CP1:** Green corrosion products, **CP2:** Red/orange corrosion products, **CP3:** Black corrosion product, **CP4:** blue corrosion product, **CP5:** Orange corrosion, **CM1:** Remaining metal

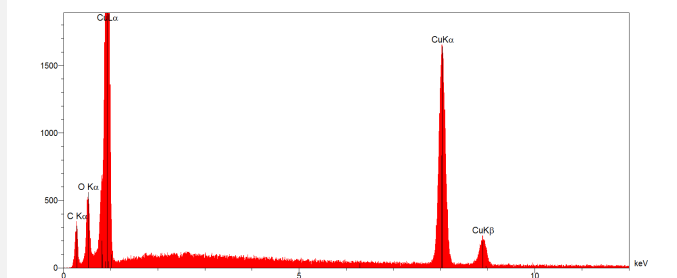
The silver enriched surface is entirely covered with copper corrosion products. The outer green layer (CP1) is a copper carbonate (Fig. 11, Table 1), while the red layers (CP2 in Fig. 15 ; CP4 and CP5 in Fig. 16) are consisting of a copper oxide, most likely cuprite (Fig. 9). Below the cuprite and above the silver enriched surface on the front face a thin black layer is present (appears grey under polarized light). SEM-EDS analysis shows that in that stratum the mercury of the pigment (Fig. 14) has been transformed into a mercury-silver compound (Figs. 7 and 10) which according to Raman spectrometry (Fig. 14) is not cinnabar anymore. In areas this silver- and mercury-rich surface has been pulled off by raising the corrosion layers, leaving structural voids that were subsequently filled by secondary corrosion products, most likely copper carbonates (Figs. 6 and 7).

Fig. 9: EDS analysis of the red corrosion layer (Fig. 4). Method of analysis: SEM-EDS, Lab of Electronic Microscopy and Microanalysis, IMA (Néode), HEI Arc,

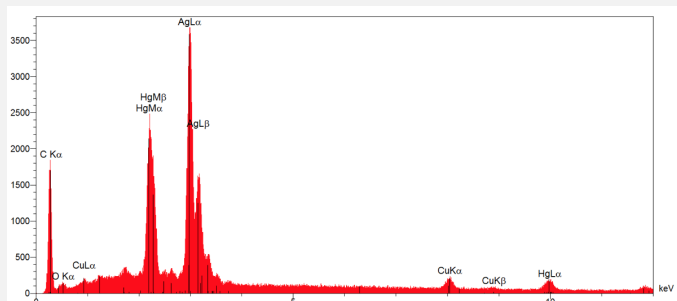
Figs. 10: EDS analysis of the layer that appears light grey under polarized light, situated below the red layer (Fig. 4). Method of analysis: SEM-EDS, Lab of Electronic Microscopy and Microanalysis, IMA (Néode), HEI Arc,

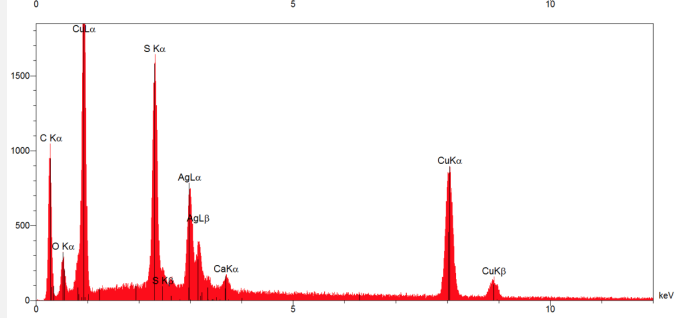
Fig. 11: EDS analysis of the green corrosion layer that has filled the structural void (Fig. 4). Method of analysis: SEM-EDS, Lab of Electronic Microscopy and Microanalysis, IMA (Néode), HEI Arc,

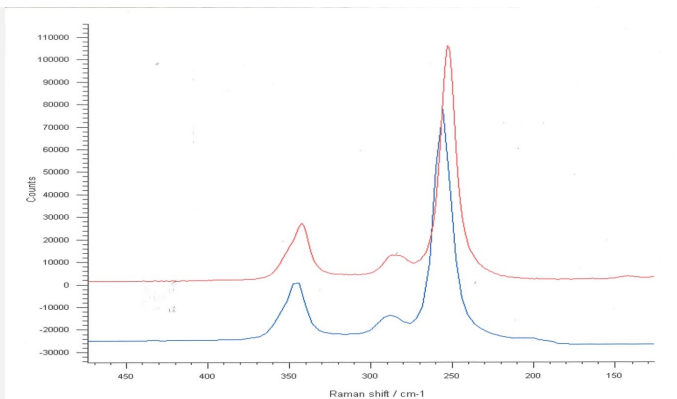
The silver sulphide (HgS, cinnabar, Fig. 13), present as a red pigment on the silver surface, could have been reduced through an electrochemical process in the presence of chlorides (Keune 2005). The released sulfur recombined with the silver to form black silver sulphide. Above that layer a porous mercury- and silver rich stratum has formed (see Hg & Ag on cartography Fig. 8). It remains unclear if the limitos is located in the silver enriched surface or within this silver-mercury compound (Fig. 7).

Fig. 13: Raman analysis of the red pigment on the surface (red line) and the references for cinnabar (blue line). Method of analysis: Raman spectroscopy, HKB,

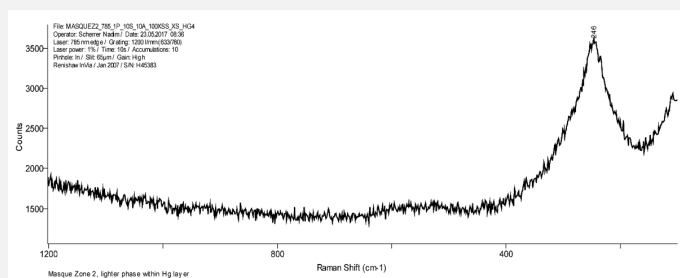
Fig. 14: Raman analysis of the mercury compounds from the cross section. Method of analysis: Raman spectroscopy, HKB,
