FUNERAL MASK IVC 11595 – CU/AG, WITH SURFACE ENRICHMENT (AG) – UNKNOWN

Artefact name Funeral mask IVC 11595

Authors Christian. Degriigny (HE-Arc CR, Neuchâtel, Neuchâtel, Switzerland) & Naima. Gutknecht (HE-Arc CR, Neuchâtel, Neuchâtel, Switzerland) & Valentin. Boissonnas (HE-Arc CR, Neuchâtel, Neuchâtel, Switzerland)

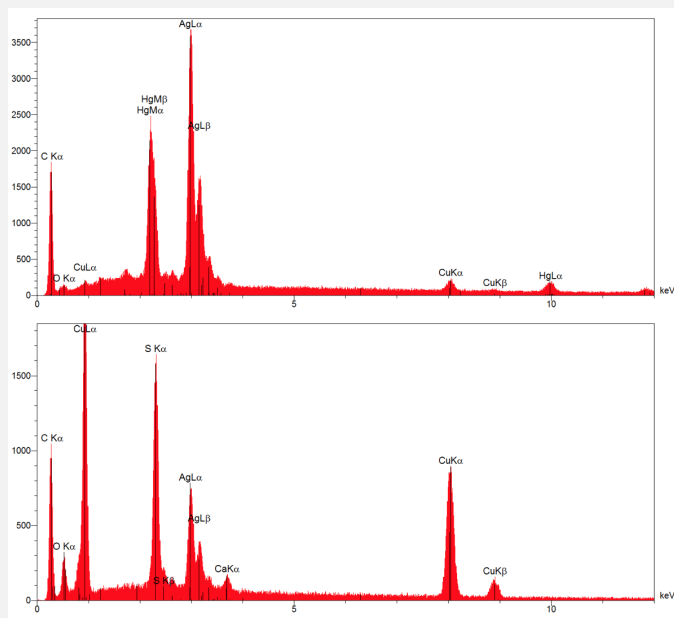
Figs. 10: EDS analysis of the layer that appears light grey under polarized light, situated below the red layer (Fig. 4). Method of analysis: SEM-EDS, Lab of Electronic Microscopy and Microanalysis, IMA (Néode), HEI Arc,

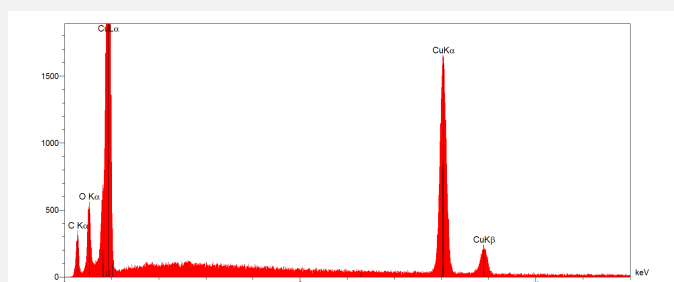
The silver enriched surface is entirely covered with copper corrosion products. The outer green layer (CP1) is a copper carbonate (Fig. 11, Table 1), while the red layers (CP2 in Fig. 15 ; CP4 and CP5 in Fig. 16) are consisting of a copper oxide, most likely cuprite (Fig. 9). Below the cuprite and above the silver enriched surface on the front face a thin black layer is present (appears grey under polarized light). SEM-EDS analysis shows that in that stratum the mercury of the pigment (Fig. 14) has been transformed into a mercury-silver compound (Figs. 7 and 10) which according to Raman spectrometry (Fig. 14) is not cinnabar anymore. In areas this silver- and mercury-rich surface has been pulled off by raising the corrosion layers, leaving structural voids that were subsequently filled by secondary corrosion products, most likely copper carbonates (Figs. 6 and 7).

Fig. 11: EDS analysis of the green corrosion layer that has filled the structural void (Fig. 4). Method of analysis: SEM-EDS, Lab of Electronic Microscopy and Microanalysis, IMA (Néode), HEI Arc,

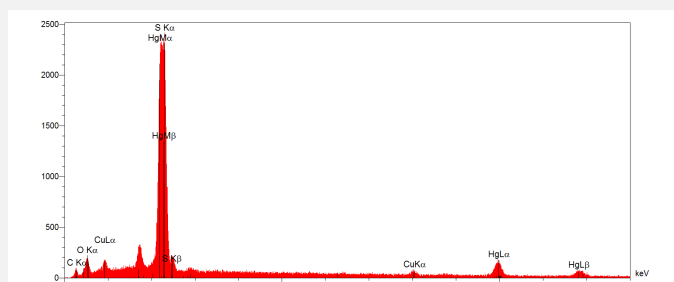
Fig. 12: EDS analysis of the red surface pigment from a surface sample. Method of analysis: SEM-EDS, Lab of Electronic Microscopy and Microanalysis, IMA (Néode), HEI Arc,

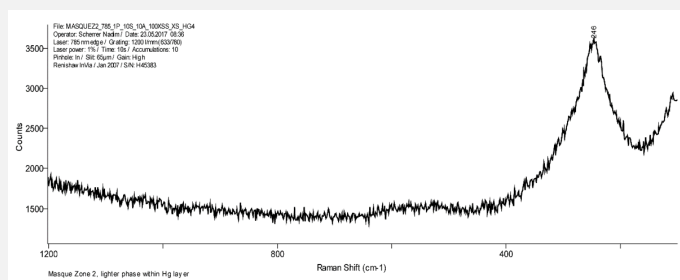
Fig. 14: Raman analysis of the mercury compounds from the cross section. Method of analysis: Raman spectroscopy, HKB,
