WEDGE PART OF AN ALTAR CROWN SUSPENSION – P-RICH IRON AND HYPOEUTECTOID STEEL – MODERN TIMES – SWITZERLAND

Wedge part of an altar crown suspension

Marianne. Senn (EMPA, Dübendorf, Zurich, Switzerland) & Christian. Degrigny (HE-Arc CR, Neuchâtel, Neuchâtel, Switzerland)

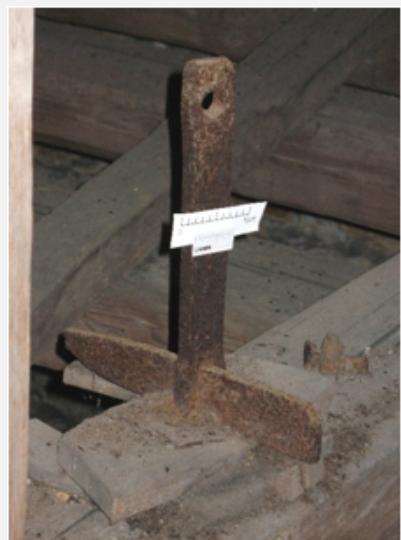
Fig. 1: Wedge part of an altar crown suspension (after Hadzic 2008,

Description of the artefact	Construction element used for suspension of an altar crown (Fig. 1).
Type of artefact	Supporting structure
Origin	Abbey of Rheinau, Zürich, Zurich, Switzerland
Recovering date	1720 AD
Chronology category	Modern Times
chronology tpq	1720 A.D. 🗸
chronology taq	🗸
Chronology comment	
Burial conditions / environment	Indoor atmosphere
Artefact location	Abbey of Rheinau, Zürich, Zurich

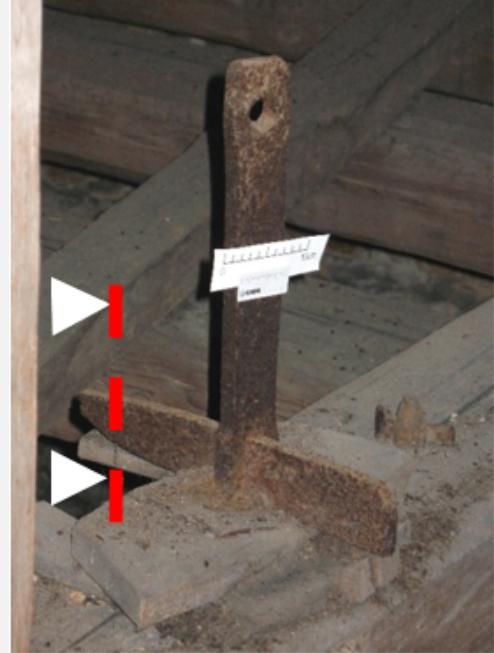
Fig. 2: Location of sampling area,

Description of sample	This sample is a section from the end of the wedge part (Fig. 2). The corrosion crust appears on the top side on Fig. 3.
Alloy	P-rich iron and hypoeutectoid steel
Technology	Annealed after (hot) rolling
Lab number of sample	RHE1-NR
Sample location	Empa (Marianne Senn)
Responsible institution	IWT (Naila Hadzic), Wallisellen, Zurich
Date and aim of sampling	January 2008, material testing and security report

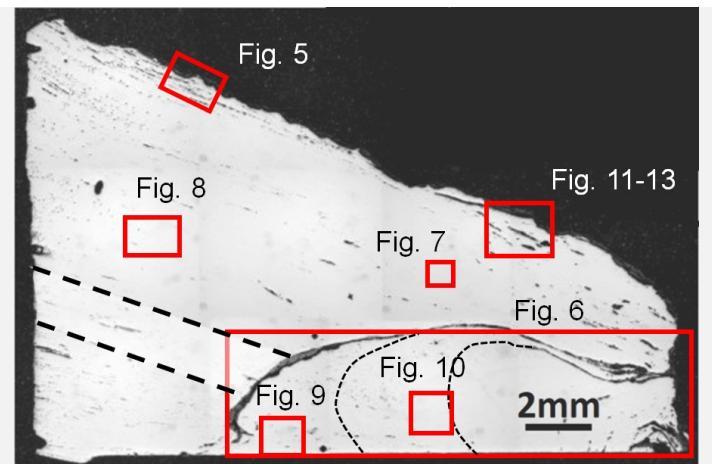
Fig. 3: Micrograph of the cross-section of the sample taken from the wedge part showing the location of Figs. 5 to 13. Steel areas are delimited by black dotted lines,

The remaining metal (M1) is a P-rich iron (0.3-0.45 mass%) with two zones (M3) consisting of soft, hypoeutectoid steel (C content 0.2 mass%) (Fig. 3 and Table 1). The P-rich iron contains many elongated slag inclusions of various sizes forming parallel rows (Figs. 3 and 5). The number of slag inclusions is higher than in bloomery iron and their distribution is typical for rolled metal. A crack, partially filled by hammer scale and corrosion products, indicates a poor quality welding seam (Fig. 3). Below the inclusions the curve produced by forging is highlighted. In good quality wrought iron slag inclusions are small, uniformly distributed and have identical compositions (Boesenberg 2006, 622). This is not the case in this sample, but can be explained by the rudimentary rolling process of the 18th century. The chemical composition of the slag inclusions shows that iron oxides dominate, beside phosphorus oxide, calcium oxide and silica (Table 2). The composition is typical for slag formed by hearth refining of pig iron (Dillmann and L'Héritier 2007). During this process, the pig iron is oxidised. The oxidising elements are Si, P, Mn, V and Cr. The analyzed slag

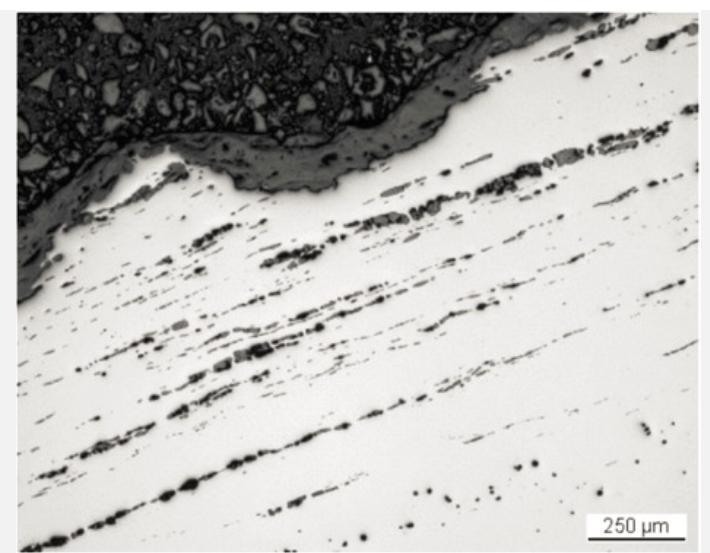
Fig. 5: Micrograph of the metal sample from Fig. 3 (reversed picture, detail), unetched, bright field. In white the metal, in grey the corrosion layer. There are numerous slag inclusions in the metal all orientated to form rows. Some inclusions are empty, probably due to sample preparation,

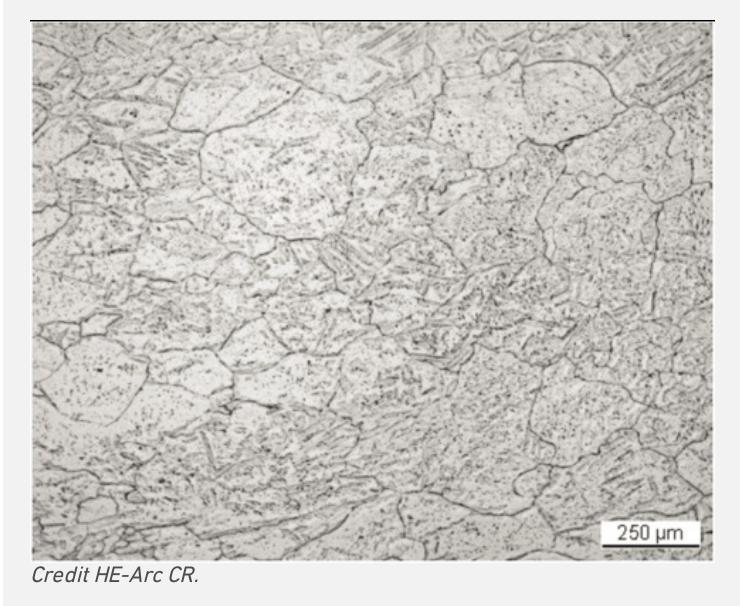
Fig. 6: Micrograph of the metal sample from Fig. 3 (reversed picture, detail), etched with Oberhoffer's reagent, bright field. The etching shows the P segregation near the welding line and outlines the irregular P distribution in the metal (white P-rich areas, dark P-poor areas),

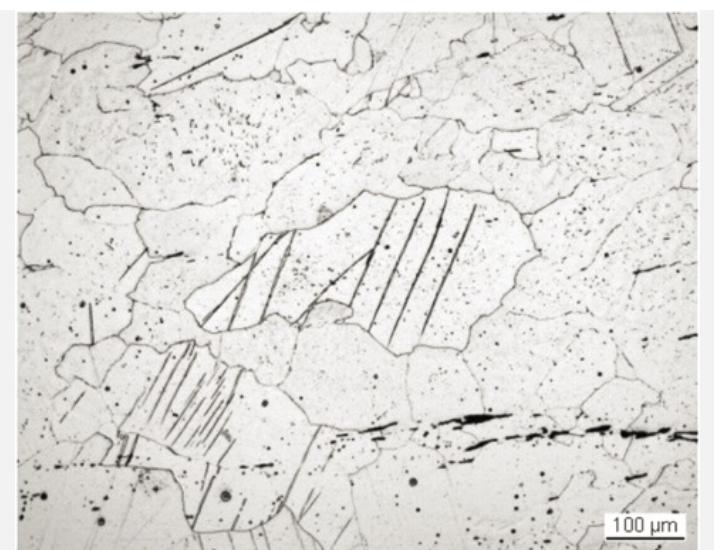
Fig. 9: Micrograph of the metal sample from Fig. 3 (detail), nital etched, bright field. The ferrite grains include Neumann bands,

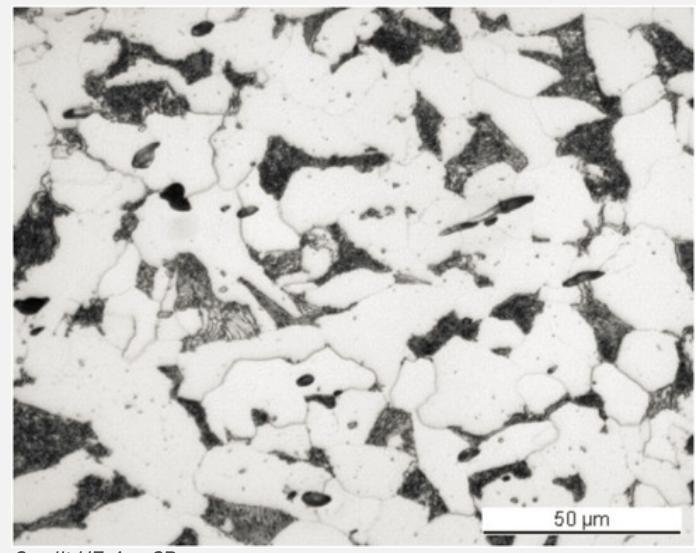
Fig. 10: Micrograph of the metal sample from Fig. 3 (detail), nital etched, bright field. The hypoeutectoid steel is constituted of ferrite in white and lamellar pearlite (in black),

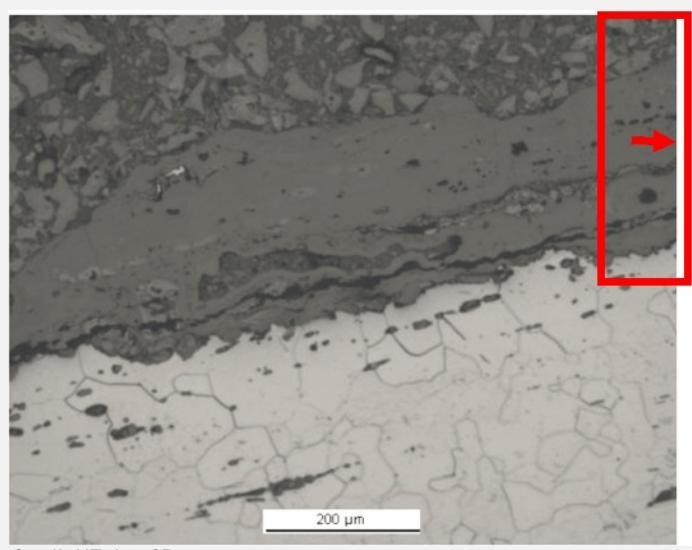
Fig. 11: Micrograph showing the metal - corrosion layer interface from Fig. 3 (reversed picture, detail), unetched, bright field. The grey corrosion layer contains bright inclusion rows. The area selected for elemental chemical distribution (Fig. 13) is marked by the red rectangle which expends beyond the micrograph,

The corrosion crust is thin and irregular. It is restricted to one of the three surfaces. In bright field, the corrosion layer seems homogeneous and appears medium-grey with a fissure parallel to the metal surface (Fig. 11). Under polarised light the corrosion products near the metal surface are mostly red-orange (CP3), whereas in the outer layer they appear orange-brown (CP1) (Fig. 12). A dark-brown zone is visible between them (CP2) and contains bright inclusions with a chemical composition similar to wüstite (Table 3). This corresponds to corroded slag inclusions (internal markers). Chemical analysis (Table 3) and elemental mapping (Fig. 13) do not highlight a difference in composition of the corrosion layers, except for the corroded slag inclusions.

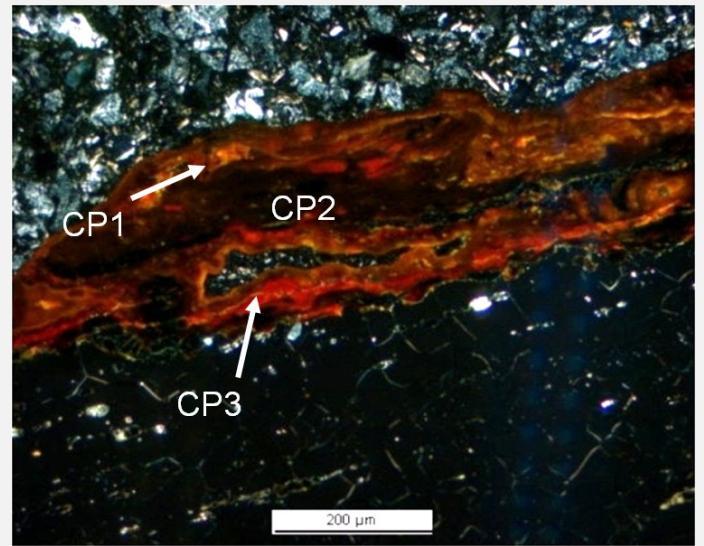
Fig. 12: Micrograph (same as Fig. 11) corresponding to the stratigraphy of Fig. 4, unetched, polarised light. We observe from bottom to top: a red-orange inner corrosion layer (CP3), followed by a dark-brown intermediate layer (CP2) and an orange-brown outer layer (CP1),

Table 3: Chemical composition (mass %) of the corrosion crust (from Fig. 12). Method of analysis: SEM/EDS, Laboratory of Analytical Chemistry, Empa.
